Access Compliance Report

Public Rights-of-Way

(Curb Ramps)

Intersection ID: 10029830	Main Street: KREFELD_DR	Cross Street: N/A	Location: S
ADA ID: 4F17ECAD7FC8	Ramp Type: PerpDiag	Initial Pass/Fail: Fail	Overall Compliance: No
Codes/Mitigation Info/Possible Solution		Field Measurements/Component Compliance

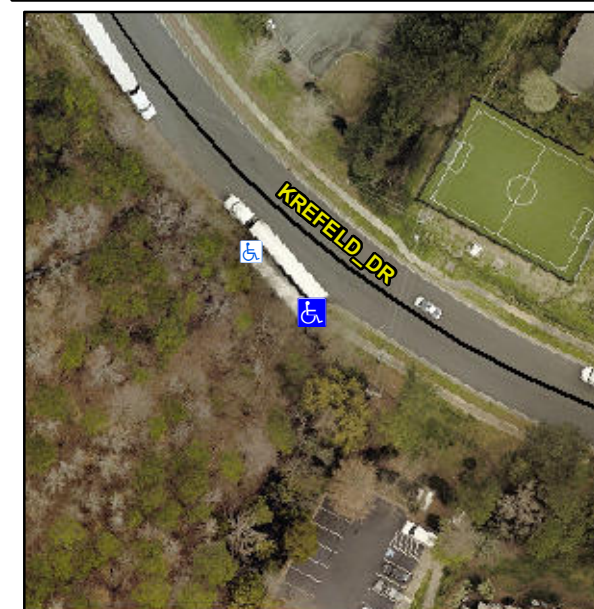
Not Found, R304.2.2

Compliance	Description	Data	Compliance	Description	Data
N/A	Ramp Length (in)	77.0	No	Ramp Slope (%)	11.1
Yes	Ramp Width (in)	48.0	Yes	Ramp XSlope (%)	3.5
N/A	Flare Type LT	N/A	N/A	Flare Type RT	N/A
N/A	Flare Slope LT (%)	N/A	N/A	Flare Slope RT (%)	N/A
N/A	Flare Traversable LT?	N/A	N/A	Flare Traversable RT?	N/A
N/A	Landing Length (in)	N/A	N/A	DWS Provided?	N/A
N/A	Landing Width (in)	N/A	N/A	DWS Contrast?	N/A
N/A	Landing Slope (%)	N/A	N/A	DWS Length (in)	N/A
N/A	Landing X Slope (%)	N/A	N/A	DWS Full Width?	N/A
N/A	Landing Curb? (Y/N)	N/A	N/A	DWS Offset (in)	N/A
N/A	Shared Landing?	N/A			
N/A	Gutter Ponding?	N/A	N/A	Gutter Slope (%)	N/A
N/A	Gutter Lip Ht (in)	N/A	N/A	Gutter X Slope (%)	N/A
N/A	Painted X Walk1?	No	N/A	Painted X Walk2?	No
	X Walk 1 Direction	To NE		X Walk 2 Direction	To NW
N/A	X Walk 1 Width (in)	N/A	N/A	X Walk 2 Width (in)	N/A
	X Walk 1 Slope (%)	1.8		X Walk 2 Slope (%)	3.0
	X Walk 1 X Slope (%)	2.7		X Walk 2 X Slope (%)	0.4

N/A	Ramp inside XWalk1?	N/A	N/A	Ramp inside XWalk2?	N/A
	Road Slope (%)	3.7	N/A	Clear Space?	N/A
	Road X Slope (%)	0.9	N/A	Clear Space to XWalk (in)	N/A
N/A	Any Obstructions?	N/A	N/A	Storm Grate/Utility Hazard?	N/A
	Obstruction Type			Storm Grate/Utility Type	
		N/A			N/A
			Yes	Surface Condition? (G/P)	Good

Remove & Replace Curb Ramp With Two New Directional Ramps or Equivalent.
