Access Compliance Report

Public Rights-of-Way

(Curb Ramps)

Intersection ID: 52246	Main Street: CENTERLINE_DR	Cross Street: KNOX_FARM_RD	Location: NW
ADA ID: 4F34C80B0635	Ramp Type: Perp	Initial Pass/Fail: Fail	Overall Compliance: No
Codes/Mitigation Info/Possible Solution		Field Measurements/Component Compliance

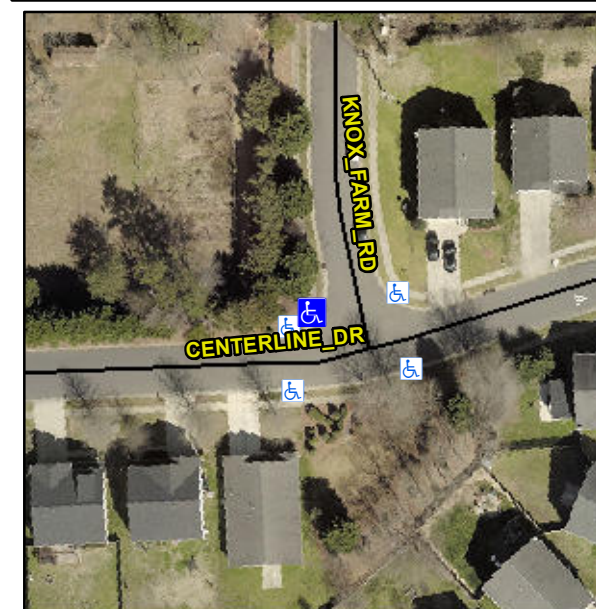
Compliance	Description	Data	Compliance	Description	Data
N/A	Ramp Length (in)	47.5	Yes	Ramp Slope (%)	6.7
No	Ramp Width (in)	36.0	Yes	Ramp XSlope (%)	0.7
N/A	Flare Type LT	N/A	N/A	Flare Type RT	N/A
N/A	Flare Slope LT (%)	N/A	N/A	Flare Slope RT (%)	N/A
N/A	Flare Traversable LT?	N/A	N/A	Flare Traversable RT?	N/A
N/A	Landing Length (in)	N/A	N/A	DWS Provided?	N/A
N/A	Landing Width (in)	N/A	N/A	DWS Contrast?	N/A
N/A	Landing Slope (%)	N/A	N/A	DWS Length (in)	N/A
N/A	Landing X Slope (%)	N/A	N/A	DWS Full Width?	N/A
N/A	Landing Curb? (Y/N)	N/A	N/A	DWS Offset (in)	N/A
N/A	Shared Landing?	N/A			
N/A	Gutter Ponding?	N/A	N/A	Gutter Slope (%)	N/A
N/A	Gutter Lip Ht (in)	N/A	N/A	Gutter X Slope (%)	N/A
N/A	Painted X Walk1?	No	N/A	Painted X Walk2?	N/A
	X Walk 1 Direction	To E		X Walk 2 Direction	N/A
N/A	X Walk 1 Width (in)	N/A	N/A	X Walk 2 Width (in)	N/A
	X Walk 1 Slope (%)	2.2		X Walk 2 Slope (%)	N/A
	X Walk 1 X Slope (%)	0.4		X Walk 2 X Slope (%)	N/A

N/A	Ramp inside XWalk1?	N/A	N/A	Ramp inside XWalk2?	N/A
	Road Slope (%)	N/A	N/A	Clear Space?	N/A
	Road X Slope (%)	N/A	N/A	Clear Space to XWalk (in)	N/A
N/A	Any Obstructions?	N/A	N/A	Storm Grate/Utility Hazard?	N/A
	Obstruction Type			Storm Grate/Utility Type	
		N/A			N/A
			Yes	Surface Condition? (G/P)	Good

Possible Solutions:

Remove & Replace Entire Ramp.

R304.5.1

\$ 1850.00
