Access Compliance Report Public Rights-of-Way (Curb Ramps)

Intersection ID: 3912 Main Street: DRIWOOD_CT Cross Street: PROSPERITY_CHURCH_RD Location: W

ADA ID: 4F3FB302D14C Ramp Type: PerpDiag Initial Pass/Fail: Pass Overall Compliance: No Severity Score: 0

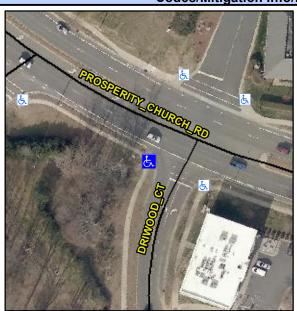
Not Found, R304.2.2-Perp, R304.3.2-Para, R305.2

| Compliance Description Data | | | Compliance Description | | Data |
|---|---|---|---|---|---|
| No | Landing Slope (%) | 3.2 | Yes | DWS Length (in) | 24.0 |
| N/A | Landing Curb? (Y/N) | No | No | DWS Offset (in) | 4.5 |

Possible Solutions:

Remove & Replace Curb Ramp With
Two New Directional Ramps or
Equivalent.

Total Cost: \$ 3200.00
