# Access Compliance Report

## Public Rights-of-Way

### (Curb Ramps)

Intersection ID: 45777	Main Street: SUGARBUSH_DR	Cross Street: CARVER_FALLS_RD	Location:	N
ADA ID: 4F4E5D74B122	Ramp Type: BlendTrans1	Initial Pass/Fail: Fail	Overall Compliance: No	Severity Score: 8.75

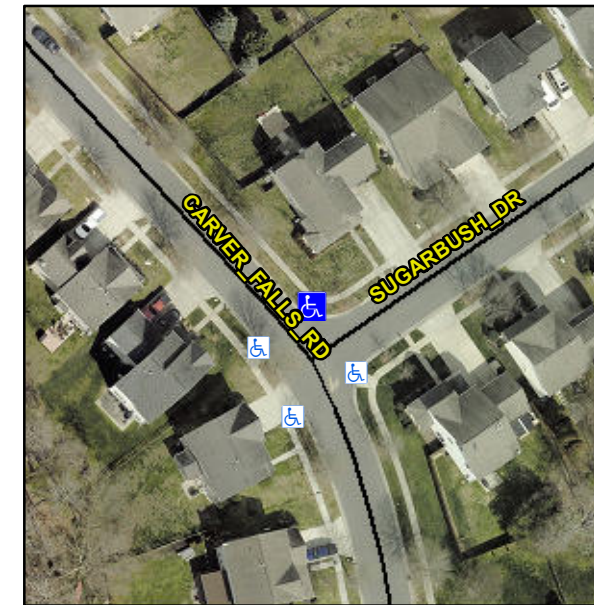
Compliance	Description	Data	Compliance	Description	Data
N/A	Ramp Length (in)	70.0	Yes	BlendTrans Slope (%)	2.2
No	Ramp Width (in)	47.5	Yes	BlendTrans XSlope (%)	1.8
N/A	Flare Type LT	N/A	N/A	Flare Type RT	N/A
N/A	Flare Slope LT (%)	N/A	N/A	Flare Slope RT (%)	N/A
N/A	Flare Traversable LT?	N/A	N/A	Flare Traversable RT?	N/A
N/A	Landing Length (in)	N/A	N/A	DWS Provided?	N/A
N/A	Landing Width (in)	N/A	N/A	DWS Contrast?	N/A
N/A	Landing Slope (%)	N/A	N/A	DWS Length (in)	N/A
N/A	Landing X Slope (%)	N/A	N/A	DWS Full Width?	N/A
N/A	Landing Curb? (Y/N)	N/A	N/A	DWS Offset (in)	N/A
N/A	Shared Landing?	N/A			
N/A	Gutter Ponding?	N/A	N/A	Gutter Slope (%)	N/A
N/A	Gutter Lip Ht (in)	N/A	N/A	Gutter X Slope (%)	N/A
N/A	Painted X Walk1?	No	N/A	Painted X Walk2?	No
	X Walk 1 Direction	To SW		X Walk 2 Direction	To SE
	X Walk 1 Width (in)	N/A		X Walk 2 Width (in)	N/A
	X Walk 1 Slope (%)	2.0		X Walk 2 Slope (%)	1.6
	X Walk 1 X Slope (%)	2.2		X Walk 2 X Slope (%)	3.0

N/A	Ramp inside XWalk1?	N/A	N/A	Ramp inside XWalk2?	N/A
	Road Slope (%)	0.6		Clear Space?	N/A
	Road X Slope (%)	2.4	N/A	Clear Space to XWalk (in)	N/A
N/A	Any Obstructions?	N/A	N/A	Storm Grate/Utility Hazard?	N/A
	Obstruction Type			Storm Grate/Utility Type	
		N/A			N/A
			Yes	Surface Condition? (G/P)	Good
			N/A	Curb Slope (%)	3.3

**Remove & Replace Curb Ramp With Two New Directional Ramps or Equivalent.**

**R304.5.1**

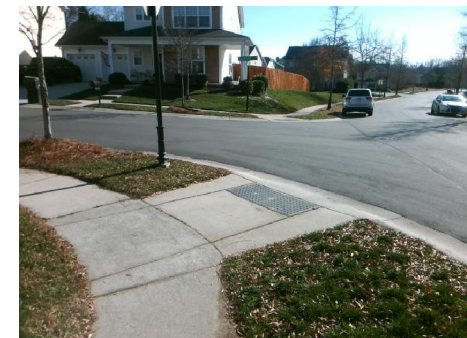
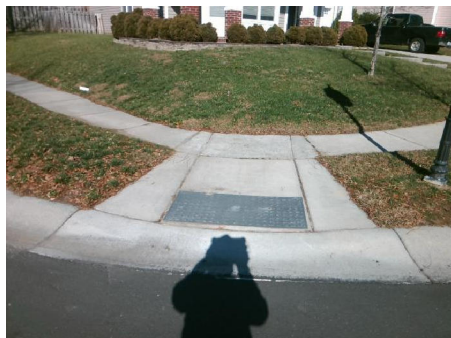
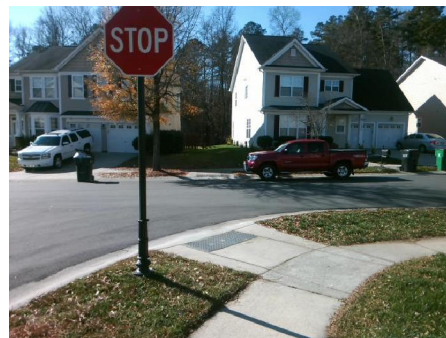
Street 1 Name **CARVER FALLS RD**  
 Stop Condition-Street 1 **None**  
 Street 2 Name **SUGARBUSH DR**  
 Stop Condition-Street 2 **StopSign**
