Access Compliance Report

Public Rights-of-Way

(Curb Ramps)

Intersection ID: 16349	Main Street: FARM_POND_LN	Cross Street: MEADOWDALE_LN	Location: SE
ADA ID: 4F51A72C527F	Ramp Type: PerpDiag	Initial Pass/Fail: Fail	Overall Compliance: No
Severity Score: 37.5			
Codes/Mitigation Info/Possible Solution		Field Measurements/Component Compliance

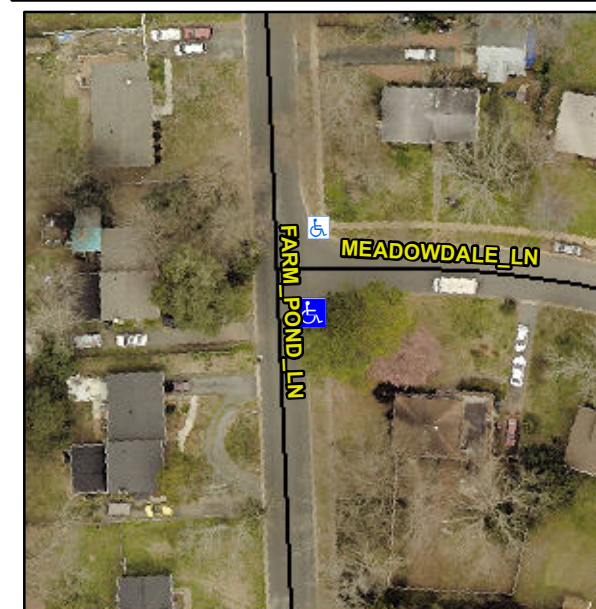
Not Found, R304.2.2, R304.5.3

Compliance	Description	Data	Compliance	Description	Data
N/A	Ramp Length (in)	39.0	No	Ramp Slope (%)	9.0
Yes	Ramp Width (in)	48.0	No	Ramp XSlope (%)	12.4
N/A	Flare Type LT	N/A	N/A	Flare Type RT	N/A
N/A	Flare Slope LT (%)	N/A	N/A	Flare Slope RT (%)	N/A
N/A	Flare Traversable LT?	N/A	N/A	Flare Traversable RT?	N/A
N/A	Landing Length (in)	N/A	N/A	DWS Provided?	N/A
N/A	Landing Width (in)	N/A	N/A	DWS Contrast?	N/A
N/A	Landing Slope (%)	N/A	N/A	DWS Length (in)	N/A
N/A	Landing X Slope (%)	N/A	N/A	DWS Full Width?	N/A
N/A	Landing Curb? (Y/N)	N/A	N/A	DWS Offset (in)	N/A
N/A	Shared Landing?	N/A			
N/A	Gutter Ponding?	N/A	N/A	Gutter Slope (%)	N/A
N/A	Gutter Lip Ht (in)	N/A	N/A	Gutter X Slope (%)	N/A
N/A	Painted X Walk1?	No	N/A	Painted X Walk2?	No
	X Walk 1 Direction	To SE		X Walk 2 Direction	To NW
N/A	X Walk 1 Width (in)	N/A	N/A	X Walk 2 Width (in)	N/A
	X Walk 1 Slope (%)	9.4		X Walk 2 Slope (%)	0.8
	X Walk 1 X Slope (%)	2.0		X Walk 2 X Slope (%)	10.0

N/A	Ramp inside XWalk1?	N/A	N/A	Ramp inside XWalk2?	N/A
	Road Slope (%)	8.1	N/A	Clear Space?	N/A
	Road X Slope (%)	7.3	N/A	Clear Space to XWalk (in)	N/A
N/A	Any Obstructions?	N/A	N/A	Storm Grate/Utility Hazard?	N/A
	Obstruction Type			Storm Grate/Utility Type	
		N/A			N/A
		Yes		Surface Condition? (G/P)	Good

Possible Solutions:

Remove & Replace Curb Ramp With Two New Directional Ramps or Equivalent.
