## **Access Compliance Report Public Rights-of-Way** (Curb Ramps)

Intersection ID: 3285 Main Street: MALLARD\_CREEK\_RD Cross Street: JOHNSTON\_OEHLER\_RD Location: W ADA ID: 4F5402E96E20 Ramp Type: Perp Initial Pass/Fail: Fail **Overall Compliance: No Severity Score:** 12.5

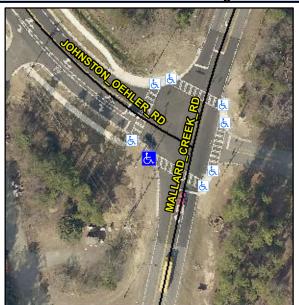
Field Measurements/Component Compliance							
Compliance Description		Data	Comp	liance Description	Data		
N/A	Ramp Length (in)	55.0	No	Ramp Slope (%)	11.3		
Yes	Ramp Width (in)	48.0	Yes	Ramp XSlope (%)	1.3		
N/A	Flare Type LT	N/A	N/A	Flare Type RT	N/A		
N/A	Flare Slope LT (%)	N/A	N/A	Flare Slope RT (%)	N/A		
N/A	Flare Traversable LT?	N/A	N/A	Flare Traversable RT?	N/A		
N/A	Landing Length (in)	N/A	N/A	DWS Provided?	N/A		
N/A	Landing Width (in)	N/A	N/A	DWS Contrast?	N/A		
N/A	Landing Slope (%)	N/A	N/A	DWS Length (in)	N/A		
N/A	Landing X Slope (%)	N/A	N/A	DWS Full Width?	N/A		
N/A	Landing Curb? (Y/N)	N/A	N/A	DWS Offset (in)	N/A		
N/A	Shared Landing?	N/A					
N/A	Gutter Ponding?	N/A	N/A	Gutter Slope (%)	N/A		
N/A	Gutter Lip Ht (in)	N/A	N/A	Gutter X Slope (%)	N/A		
N/A	Painted X Walk1?	Yes	N/A	Painted X Walk2?	N/A		
	X Walk 1 Direction	To SE		X Walk 2 Direction	N/A		
N/A	X Walk 1 Width (in)	106.0	N/A	X Walk 2 Width (in)	N/A

X Walk 1 Slope (%)	2.5		X Walk 2 Slope (%)	N/A		
	X Walk 1 X Slope (%)	4.8		X Walk 2 X Slope (%)	N/A		
N/A	Ramp inside XWalk1?	Yes	N/A	Ramp inside XWalk2?	N/A		
	Road Slope (%)	N/A	N/A	Clear Space?	N/A		
	Road X Slope (%)	N/A	N/A	Clear Space to XWalk (in)	N/A		
N/A	Any Obstructions?	N/A	N/A	Storm Grate/Utility Hazard?	N/A		
	Obstruction Type			Storm Grate/Utility Type			
		N/A			N/A		
			Yes	Surface Condition? (G/P)	Good

À	Possible Solutions:				
いった人人とはいるが、	Remove & Replace Entire Ramp.				
į,	Surveyor Notes:				
Stands of	N/A				
gi g	PROW/ADA:				
	R304.2.2

Total Cost: 1850.00
