Access Compliance Report Public Rights-of-Way (Curb Ramps)

Intersection ID: 44275 Main Street: JOSEPH_HOWARD_CT Cross Street: BRITTNI_DAYLE_DR Location: E

ADA ID: 4F601E8A9384 Ramp Type: PerpDiag Initial Pass/Fail: Fail Overall Compliance: No Severity Score: 10

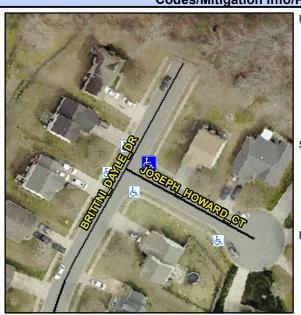
Not Found, R304.5.1, R304.5.3

Field Measure	ements/C	ompoi	nent Compliance	
Compl	iance Description	Data	Comp	liance Description	Data
N/A	Ramp Length (in)	47.0	Yes	Ramp Slope (%)	5.0
No	Ramp Width (in)	41.5	No	Ramp XSlope (%)	2.1
N/A	Flare Type LT	N/A	N/A	Flare Type RT	N/A
N/A	Flare Slope LT (%)	N/A	N/A	Flare Slope RT (%)	N/A
N/A	Flare Traversable LT?	N/A	N/A	Flare Traversable RT?	N/A
N/A	Landing Length (in)	N/A	N/A	DWS Provided?	N/A
N/A	Landing Width (in)	N/A	N/A	DWS Contrast?	N/A
N/A	Landing Slope (%)	N/A	N/A	DWS Length (in)	N/A
N/A	Landing X Slope (%)	N/A	N/A	DWS Full Width?	N/A
N/A	Landing Curb? (Y/N)	N/A	N/A	DWS Offset (in)	N/A
N/A	Shared Landing?	N/A			
N/A	Gutter Ponding?	N/A	N/A	Gutter Slope (%)	N/A
N/A	Gutter Lip Ht (in)	N/A	N/A	Gutter X Slope (%)	N/A
N/A	Painted X Walk1?	No	N/A	Painted X Walk2?	No
	X Walk 1 Direction	To NW		X Walk 2 Direction	To SW
N/A	X Walk 1 Width (in)	N/A	N/A	X Walk 2 Width (in)	N/A
	X Walk 1 Slope (%)	4.2		X Walk 2 Slope (%)	0.9

X Walk 1 X Slope (%)	0.7		X Walk 2 X Slope (%)	1.6
N/A	Ramp inside XWalk1?	N/A	N/A	Ramp inside XWalk2?	N/A
	Road Slope (%)	1.7	N/A	Clear Space?	N/A
	Road X Slope (%)	2.1	N/A	Clear Space to XWalk (in)	N/A
N/A	Any Obstructions?	N/A	N/A	Storm Grate/Utility Hazard?	N/A
	Obstruction Type			Storm Grate/Utility Type	
		N/A			N/A
			Yes	Surface Condition? (G/P)	Good

Remove & Replace Curb Ramp With Two New Directional Ramps or Equivalent.
