Access Compliance Report

Public Rights-of-Way

(Curb Ramps)

Intersection ID: 12695	Main Street: S_CALDWELL_ST	Cross Street: E TRADE ST	Location: SE
ADA ID: 4F60834F7C26	Ramp Type: Perp	Initial Pass/Fail: Pass	Overall Compliance: No
Codes/Mitigation Info/Possible Solution		Field Measurements/Component Compliance	
Severity Score: 2.5

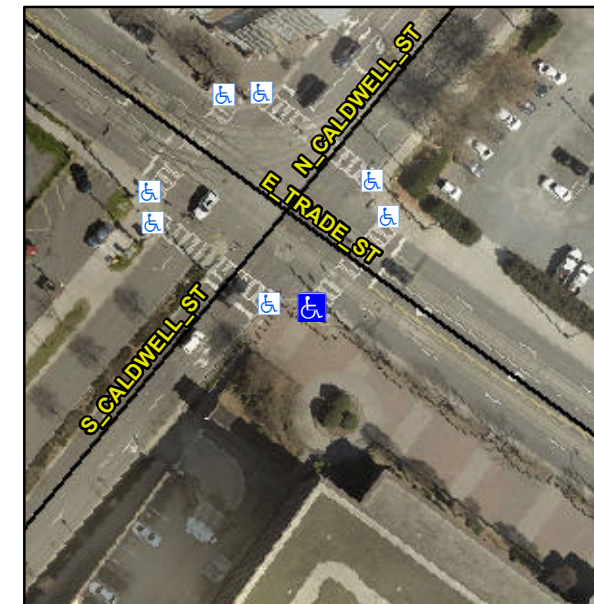
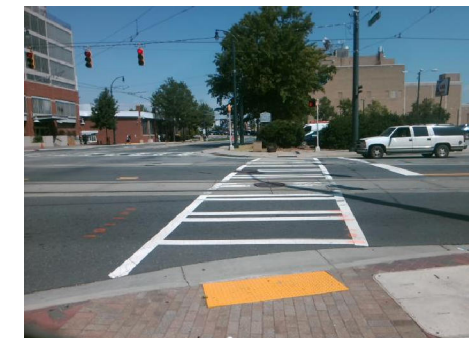
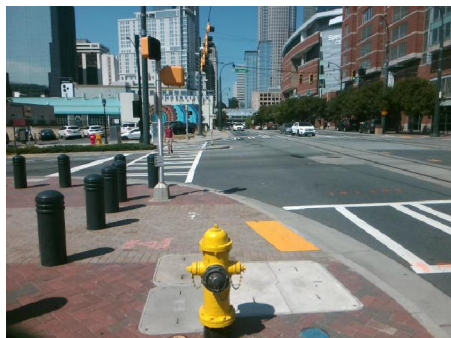
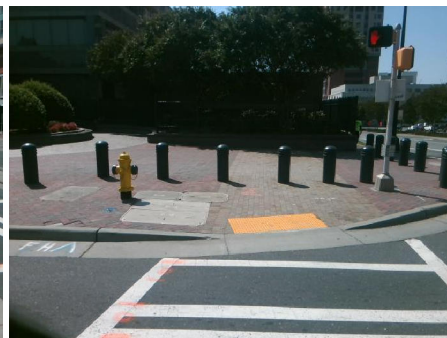
Not Found, R304.2.2-Perp, R304.3.2-Para, R305.1.4

Compliance	Description	Data	Compliance	Description	Data
N/A	Ramp Length (in)	24.0	Yes	Ramp Slope (%)	6.0
Yes	Ramp Width (in)	72.0	Yes	Ramp XSlope (%)	0.4
N/A	Flare Type LT	Sloped	N/A	Flare Type RT	N/A
N/A	Flare Slope LT (%)	6.9	Yes	Flare Slope RT (%)	7.8
N/A	Flare Traversable LT?	Yes	N/A	Flare Traversable RT?	Yes
Yes	Landing Length (in)	48.0	Yes	DWS Provided?	Yes
Yes	Landing Width (in)	72.0	Yes	DWS Contrast?	Yes
No	Landing Slope (%)	2.6	Yes	DWS Length (in)	24.5
Yes	Landing X Slope (%)	1.2	No	DWS Full Width?	No
N/A	Landing Curb? (Y/N)	No	Yes	DWS Offset (in)	1.0
N/A	Shared Landing?	No			
Yes	Gutter Ponding?	No	Yes	Gutter Slope (%)	0.4
Yes	Gutter Lip Ht (in)	0.0	Yes	Gutter X Slope (%)	0.3
N/A	Painted X Walk1?	Yes	N/A	Painted X Walk2?	N/A
	X Walk 1 Direction	To NE		X Walk 2 Direction	N/A
N/A	X Walk 1 Width (in)	117.0	N/A	X Walk 2 Width (in)	N/A
	X Walk 1 Slope (%)	7.7		X Walk 2 Slope (%)	N/A
	X Walk 1 X Slope (%)	0.3		X Walk 2 X Slope (%)	N/A

Yes	Ramp inside XWalk1?	Yes	N/A	Ramp inside XWalk2?	N/A
	Road Slope (%)	N/A	N/A	Clear Space?	Yes
	Road X Slope (%)	N/A	N/A	Clear Space to XWalk (in)	N/A
Yes	Any Obstructions?	No	Yes	Storm Grate/Utility Hazard?	No
	Obstruction Type			Storm Grate/Utility Type	
		N/A			N/A
			Yes	Surface Condition? (G/P)	Good

Possible Solutions:

Remove & Replace Entire Ramp.
