Access Compliance Report

Public Rights-of-Way

(Curb Ramps)

Intersection ID: 48858	Main Street: SHALLOW_WELL_DR	Cross Street: FENCELINE_DR	Location:	NW
ADA ID: 4F685C2E7A48	Ramp Type: BlendTrans2	Initial Pass/Fail: Fail	Overall Compliance: No	Severity Score: 12.5
Codes/Mitigation Info/Possible Solution		Field Measurements/Component Compliance

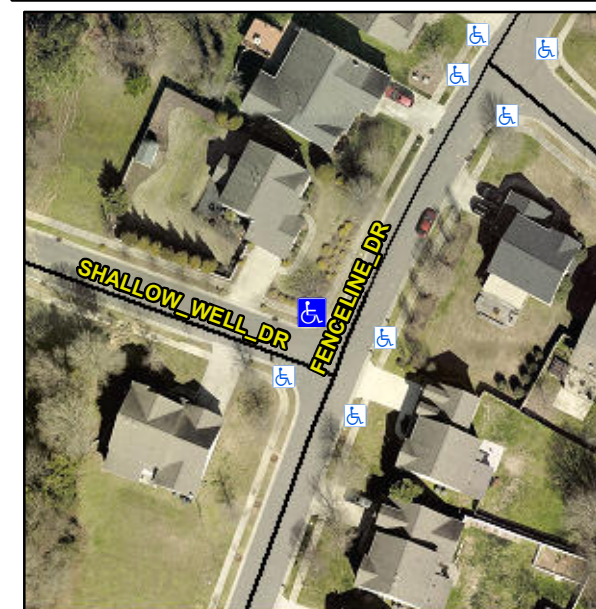
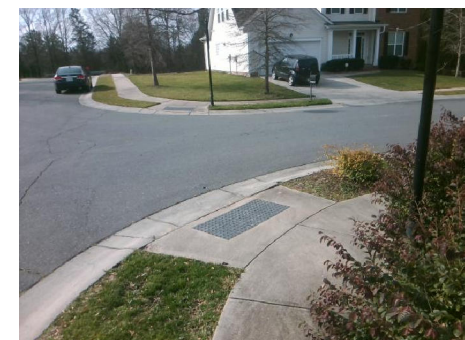
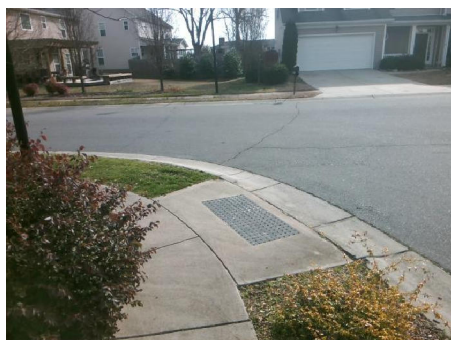
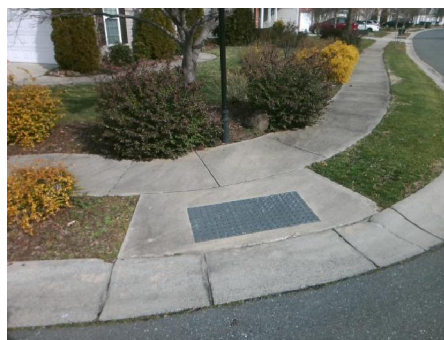
Compliance	Description	Data	Compliance	Description	Data
N/A	Ramp Length (in)	45.0	Yes	BlendTrans Slope (%)	4.8
Yes	Ramp Width (in)	48.0	No	BlendTrans XSlope (%)	5.4
N/A	Flare Type LT	N/A	N/A	Flare Type RT	N/A
N/A	Flare Slope LT (%)	N/A	N/A	Flare Slope RT (%)	N/A
N/A	Flare Traversable LT?	N/A	N/A	Flare Traversable RT?	N/A
N/A	Landing Length (in)	N/A	N/A	DWS Provided?	N/A
N/A	Landing Width (in)	N/A	N/A	DWS Contrast?	N/A
N/A	Landing Slope (%)	N/A	N/A	DWS Length (in)	N/A
N/A	Landing X Slope (%)	N/A	N/A	DWS Full Width?	N/A
N/A	Landing Curb? (Y/N)	N/A	N/A	DWS Offset (in)	N/A
N/A	Shared Landing?	N/A			
N/A	Gutter Ponding?	N/A	N/A	Gutter Slope (%)	N/A
N/A	Gutter Lip Ht (in)	N/A	N/A	Gutter X Slope (%)	N/A
N/A	Painted X Walk1?	No	N/A	Painted X Walk2?	No
	X Walk 1 Direction	To SW		X Walk 2 Direction	To SE
	X Walk 1 Width (in)	N/A		X Walk 2 Width (in)	N/A
	X Walk 1 Slope (%)	2.7		X Walk 2 Slope (%)	5.6
	X Walk 1 X Slope (%)	4.0		X Walk 2 X Slope (%)	0.9

N/A	Ramp inside XWalk1?	N/A	N/A	Ramp inside XWalk2?	N/A
	Road Slope (%)	2.3		Clear Space?	N/A
	Road X Slope (%)	2.5	N/A	Clear Space to XWalk (in)	N/A
N/A	Any Obstructions?	N/A	N/A	Storm Grate/Utility Hazard?	N/A
	Obstruction Type			Storm Grate/Utility Type	
		N/A			N/A
			Yes	Surface Condition? (G/P)	Good
			N/A	Curb Slope (%)	2.1

Possible Solutions:

Remove & Replace Curb Ramp With Two New Directional Ramps or Equivalent.

R304.5.3
