# Access Compliance Report

## Public Rights-of-Way

### (Curb Ramps)

Intersection ID: 13468	Main Street: W_PARK_AV	Cross Street: WICKFORD_PL	Location:	N
ADA ID: 4F693F544F3D	Ramp Type: Perp	Initial Pass/Fail: Fail	Overall Compliance: No	Severity Score: 12.5
Codes/Mitigation Info/Possible Solution		Field Measurements/Component Compliance

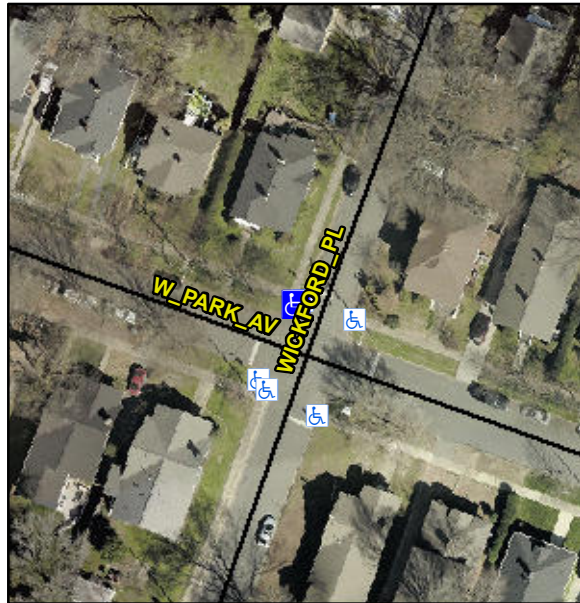
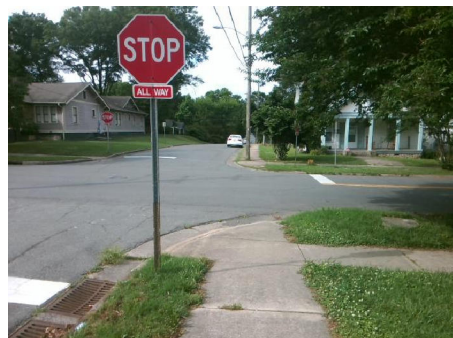
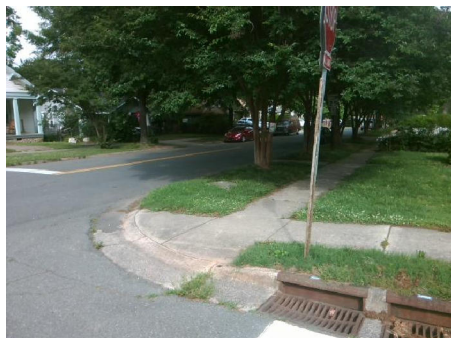
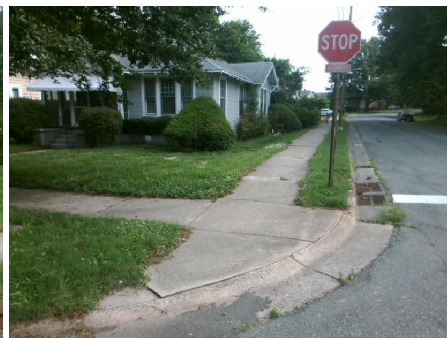
**Not Found, R304.2.2**

Compliance	Description	Data	Compliance	Description	Data
N/A	Ramp Length (in)	122.0	No	Ramp Slope (%)	9.6
Yes	Ramp Width (in)	60.0	Yes	Ramp XSlope (%)	0.5
N/A	Flare Type LT	N/A	N/A	Flare Type RT	N/A
N/A	Flare Slope LT (%)	N/A	N/A	Flare Slope RT (%)	N/A
N/A	Flare Traversable LT?	N/A	N/A	Flare Traversable RT?	N/A
N/A	Landing Length (in)	N/A	N/A	DWS Provided?	N/A
N/A	Landing Width (in)	N/A	N/A	DWS Contrast?	N/A
N/A	Landing Slope (%)	N/A	N/A	DWS Length (in)	N/A
N/A	Landing X Slope (%)	N/A	N/A	DWS Full Width?	N/A
N/A	Landing Curb? (Y/N)	N/A	N/A	DWS Offset (in)	N/A
N/A	Shared Landing?	N/A			
N/A	Gutter Ponding?	N/A	N/A	Gutter Slope (%)	N/A
N/A	Gutter Lip Ht (in)	N/A	N/A	Gutter X Slope (%)	N/A
N/A	Painted X Walk1?	No	N/A	Painted X Walk2?	N/A
	X Walk 1 Direction	To SW		X Walk 2 Direction	N/A
N/A	X Walk 1 Width (in)	N/A	N/A	X Walk 2 Width (in)	N/A
	X Walk 1 Slope (%)	5.4		X Walk 2 Slope (%)	N/A
	X Walk 1 X Slope (%)	3.3		X Walk 2 X Slope (%)	N/A

N/A	Ramp inside XWalk1?	N/A	N/A	Ramp inside XWalk2?	N/A
	Road Slope (%)	N/A	N/A	Clear Space?	N/A
	Road X Slope (%)	N/A	N/A	Clear Space to XWalk (in)	N/A
N/A	Any Obstructions?	N/A	N/A	Storm Grate/Utility Hazard?	N/A
	Obstruction Type			Storm Grate/Utility Type	
		N/A			N/A
			Yes	Surface Condition? (G/P)	Good

**Remove & Replace Entire Ramp.**

Total Cost: \$ 1850.00
