# Access Compliance Report

## Public Rights-of-Way

### (Curb Ramps)

| Intersection ID: 14258 | Main Street: BERKELEY_AV | Cross Street: LAFAYETTE_AV | Location: NW |

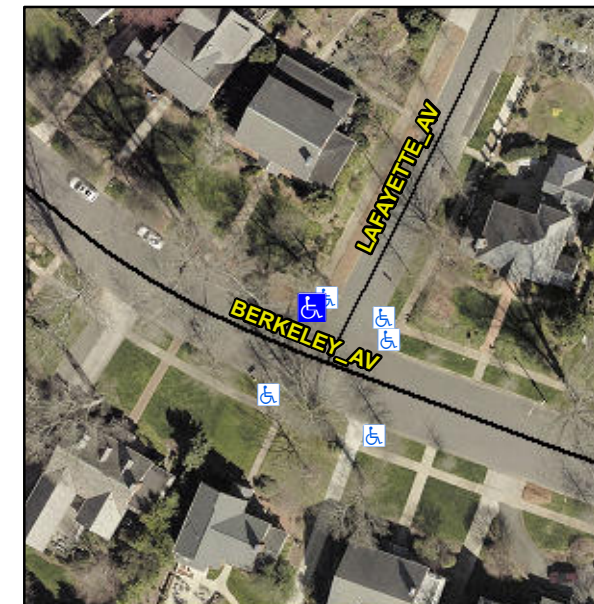
| Compliance | Description | Data | Compliance | Description | Data |
|---|---|---|---|---|---|
| Yes | Landing X Slope (%) | 0.9 | No | DWS Full Width? | No |
| N/A | Shared Landing? | Yes | No | DWS Offset RT (in) | 3.0 |
| No | Gutter Ponding? | Yes | No | Gutter Slope (%) | 5.8 |

**Remove & Replace Detectable Warning System. Remove & Replace Gutter.**

**R305.1.4, R305.2, R302.7, R304.5.4**
