Access Compliance Report

Public Rights-of-Way

(Curb Ramps)

Intersection ID: 6508	Main Street: MISTY_CREEK_DR	Cross Street: STATESVILLE_RD	Location: SW
ADA ID: 4F84E0AA8D05	Ramp Type: Perp	Initial Pass/Fail: Fail	Overall Compliance: No
			Severity Score: 33.75

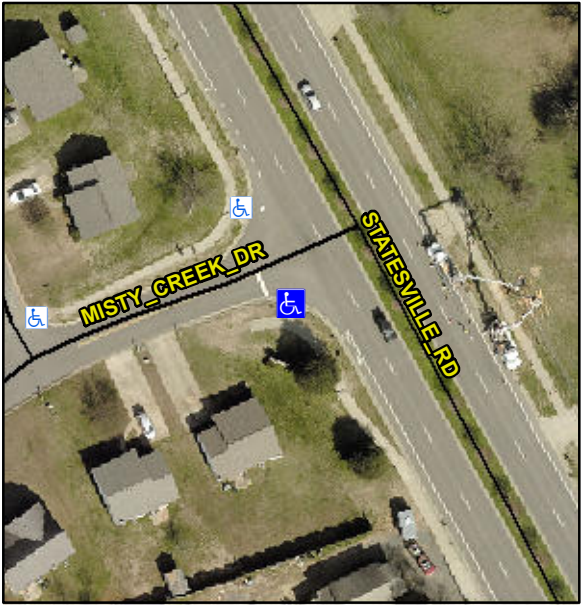
Possible Solutions:		Compliance	Description	Data
	Remove & Replace Entire Ramp.		No	Ramp Length (in)	95.0
			No	Ramp Width (in)	46.5
			N/A	Flare Type LT	N/A
			N/A	Flare Slope LT (%)	N/A
			N/A	Flare Traversable LT?	N/A
			N/A	Landing Length (in)	N/A
			N/A	Landing Width (in)	N/A
			N/A	Landing Slope (%)	N/A
			N/A	Landing X Slope (%)	N/A
<p>Surveyor Notes:</p> <p>N/A</p> <p>PROW/ADA:</p> <p>Not Found, R304.5.1, R304.2.2, R304.5.3</p>			N/A	Flare Type RT	N/A
			N/A	Flare Slope RT (%)	N/A
			N/A	Flare Traversable RT?	N/A
			N/A	DWS Provided?	N/A
			N/A	DWS Contrast?	N/A
			N/A	DWS Length (in)	N/A
			N/A	DWS Full Width?	N/A
			N/A	DWS Offset (in)	N/A
			N/A	Gutter Ponding?	N/A
			N/A	Gutter Lip Ht (in)	0.5
<p>Total Cost:</p> <p>\$ 1850.00</p>			No	Painted X Walk1?	N/A
			N/A	X Walk 1 Direction	To N
			N/A	X Walk 1 Width (in)	N/A

N/A	X Walk 1 Slope (%)	0.1
			N/A	X Walk 1 X Slope (%)	4.1
			N/A	Ramp inside XWalk1?	N/A
			N/A	Road Slope (%)	N/A
			N/A	Road X Slope (%)	N/A
			N/A	Any Obstructions?	N/A
			N/A	Obstruction Type	N/A
			N/A	Clear Space?	N/A
			N/A	Clear Space to XWalk (in)	N/A
			N/A	Storm Grate/Utility Hazard?	N/A
			N/A	Storm Grate/Utility Type	N/A
			Yes	Surface Condition? (G/P)	Good
