Access Compliance Report

Public Rights-of-Way

(Curb Ramps)

Intersection ID: 32316	Main Street: NEW_PROVIDENCE_LN	Cross Street: WOODCLIFF_CT	Location: W
ADA ID: 4F8B4EFA19C1	Ramp Type: PerpDiag	Initial Pass/Fail: Fail	Overall Compliance: No
			Severity Score: 46.25

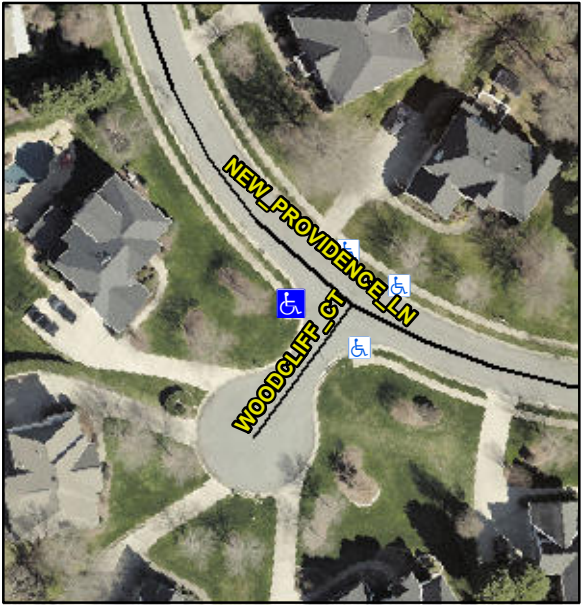
Possible Solutions:		Compliance	Description	Data
	Remove & Replace Curb Ramp With Two New Directional Ramps or Equivalent.		No	Ramp Length (in)	52.0
			No	Ramp Width (in)	43.0
			N/A	Flare Type LT	N/A
			N/A	Flare Slope LT (%)	N/A
			N/A	Flare Traversable LT?	N/A
			N/A	Landing Length (in)	N/A
			N/A	Landing Width (in)	N/A
			N/A	Landing Slope (%)	N/A
			N/A	Landing X Slope (%)	N/A
			N/A	Landing Curb? (Y/N)	N/A
			N/A	Shared Landing?	N/A
			N/A	Gutter Ponding?	N/A
			N/A	Gutter Lip Ht (in)	2.5
			N/A	Painted X Walk1?	No
				X Walk 1 Direction	To SE
			N/A	X Walk 1 Width (in)	N/A
				X Walk 1 Slope (%)	3.6
				X Walk 1 X Slope (%)	4.7
			N/A	Ramp inside XWalk1?	N/A
<p>Surveyor Notes:</p> <p>N/A</p> <p>PROW/ADA:</p> <p>R304.5.1, R304.2.2, R304.5.3</p>			N/A	Flare Type RT	N/A
			N/A	Flare Slope RT (%)	N/A
			N/A	Flare Traversable RT?	N/A

N/A	DWS Provided?	N/A
			N/A	DWS Contrast?	N/A
			N/A	DWS Length (in)	N/A
			N/A	DWS Full Width?	N/A
			N/A	DWS Offset (in)	N/A
			N/A	Gutter Slope (%)	N/A
			N/A	Gutter X Slope (%)	N/A
			N/A	Painted X Walk2?	No
				X Walk 2 Direction	To NE
			N/A	X Walk 2 Width (in)	N/A
				X Walk 2 Slope (%)	2.8
				X Walk 2 X Slope (%)	4.1
			N/A	Ramp inside XWalk2?	N/A
			N/A	Clear Space?	N/A
			N/A	Clear Space to XWalk (in)	N/A
			N/A	Storm Grate/Utility Hazard?	N/A
				Storm Grate/Utility Type	
<p>Total Cost:</p> <p>\$ 3200.00</p>			N/A		N/A
			Yes	Surface Condition? (G/P)	Good
