Access Compliance Report

Public Rights-of-Way

(Curb Ramps)

Intersection ID: 44190	Main Street: ROZZELLES_LANDING_DR	Cross Street: CODDINGTON_RIDGE_DR	Location: NE
ADA ID: 4F98504F6D90	Ramp Type: BlendTrans1	Initial Pass/Fail: Fail	Overall Compliance: No
Severity Score: 8.75			
Codes/Mitigation Info/Possible Solution		Field Measurements/Component Compliance

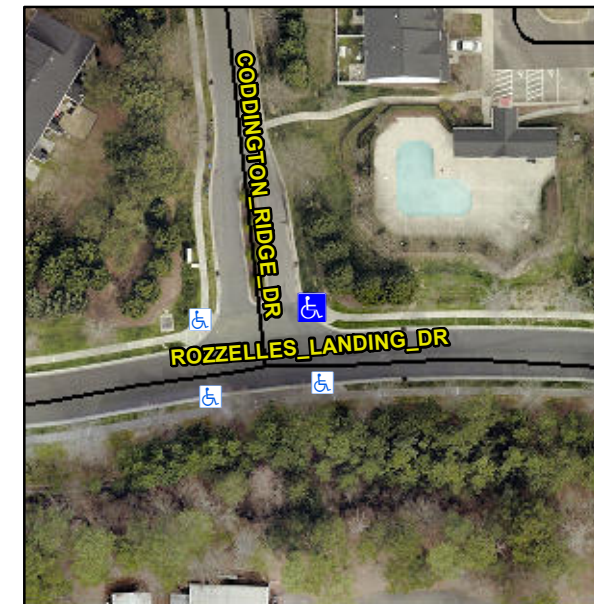
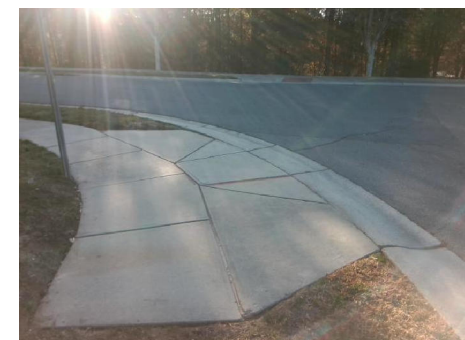
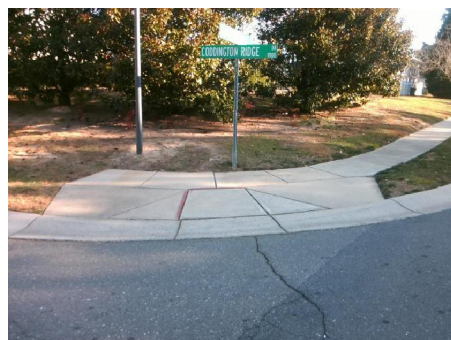
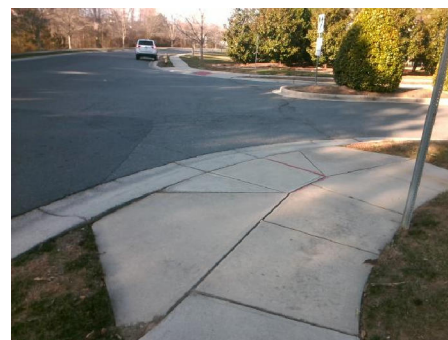
Compliance	Description	Data	Compliance	Description	Data
N/A	Ramp Length (in)	48.0	Yes	BlendTrans Slope (%)	4.5
No	Ramp Width (in)	36.0	Yes	BlendTrans XSlope (%)	1.2
N/A	Flare Type LT	N/A	N/A	Flare Type RT	N/A
N/A	Flare Slope LT (%)	N/A	N/A	Flare Slope RT (%)	N/A
N/A	Flare Traversable LT?	N/A	N/A	Flare Traversable RT?	N/A
N/A	Landing Length (in)	N/A	N/A	DWS Provided?	N/A
N/A	Landing Width (in)	N/A	N/A	DWS Contrast?	N/A
N/A	Landing Slope (%)	N/A	N/A	DWS Length (in)	N/A
N/A	Landing X Slope (%)	N/A	N/A	DWS Full Width?	N/A
N/A	Landing Curb? (Y/N)	N/A	N/A	DWS Offset (in)	N/A
N/A	Shared Landing?	N/A			
N/A	Gutter Ponding?	N/A	N/A	Gutter Slope (%)	N/A
N/A	Gutter Lip Ht (in)	N/A	N/A	Gutter X Slope (%)	N/A
N/A	Painted X Walk1?	No	N/A	Painted X Walk2?	No
	X Walk 1 Direction	To W		X Walk 2 Direction	To S
	X Walk 1 Width (in)	N/A		X Walk 2 Width (in)	N/A
	X Walk 1 Slope (%)	0.5		X Walk 2 Slope (%)	3.1
	X Walk 1 X Slope (%)	2.9		X Walk 2 X Slope (%)	0.6

N/A	Ramp inside XWalk1?	N/A	N/A	Ramp inside XWalk2?	N/A
	Road Slope (%)	0.7		Clear Space?	N/A
	Road X Slope (%)	1.3	N/A	Clear Space to XWalk (in)	N/A
N/A	Any Obstructions?	N/A	N/A	Storm Grate/Utility Hazard?	N/A
	Obstruction Type			Storm Grate/Utility Type	
		N/A			N/A
			Yes	Surface Condition? (G/P)	Good
			N/A	Curb Slope (%)	4.2

Remove & Replace Curb Ramp With Two New Directional Ramps or Equivalent.

R304.5.1
