Access Compliance Report

Public Rights-of-Way

(Curb Ramps)

Intersection ID: 3221	Main Street: FAIRBOURNE_CT	Cross Street: HIGHCROFT_LN	Location:	NE
ADA ID: 4FA347089E4D	Ramp Type: Perp	Initial Pass/Fail: Fail	Overall Compliance: No	Severity Score: 10
Codes/Mitigation Info/Possible Solution		Field Measurements/Component Compliance

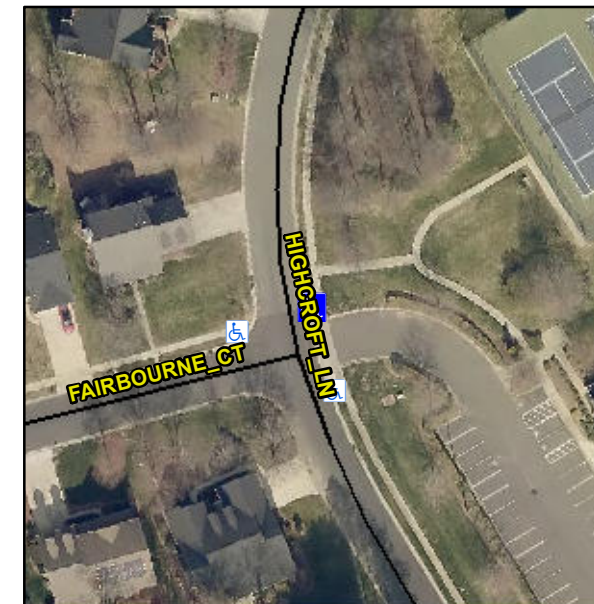
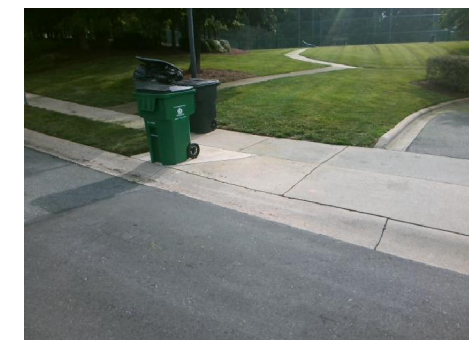
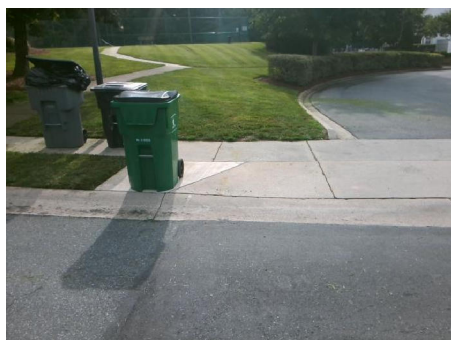
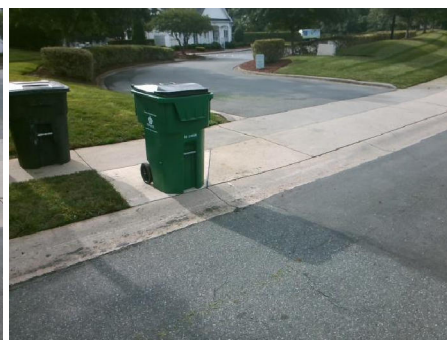
Not Found, R304.5.1

Compliance	Description	Data	Compliance	Description	Data
N/A	Ramp Length (in)	48.0	Yes	Ramp Slope (%)	6.9
No	Ramp Width (in)	41.0	Yes	Ramp XSlope (%)	2.4
N/A	Flare Type LT	N/A	N/A	Flare Type RT	N/A
N/A	Flare Slope LT (%)	N/A	N/A	Flare Slope RT (%)	N/A
N/A	Flare Traversable LT?	N/A	N/A	Flare Traversable RT?	N/A
N/A	Landing Length (in)	N/A	N/A	DWS Provided?	N/A
N/A	Landing Width (in)	N/A	N/A	DWS Contrast?	N/A
N/A	Landing Slope (%)	N/A	N/A	DWS Length (in)	N/A
N/A	Landing X Slope (%)	N/A	N/A	DWS Full Width?	N/A
N/A	Landing Curb? (Y/N)	N/A	N/A	DWS Offset (in)	N/A
N/A	Shared Landing?	N/A			
N/A	Gutter Ponding?	N/A	N/A	Gutter Slope (%)	N/A
N/A	Gutter Lip Ht (in)	N/A	N/A	Gutter X Slope (%)	N/A
N/A	Painted X Walk1?	No	N/A	Painted X Walk2?	N/A
	X Walk 1 Direction	To W		X Walk 2 Direction	N/A
N/A	X Walk 1 Width (in)	N/A	N/A	X Walk 2 Width (in)	N/A
	X Walk 1 Slope (%)	2.9		X Walk 2 Slope (%)	N/A
	X Walk 1 X Slope (%)	3.9		X Walk 2 X Slope (%)	N/A

N/A	Ramp inside XWalk1?	N/A	N/A	Ramp inside XWalk2?	N/A
	Road Slope (%)	N/A	N/A	Clear Space?	N/A
	Road X Slope (%)	N/A	N/A	Clear Space to XWalk (in)	N/A
N/A	Any Obstructions?	N/A	N/A	Storm Grate/Utility Hazard?	N/A
	Obstruction Type			Storm Grate/Utility Type	
		N/A			N/A
			Yes	Surface Condition? (G/P)	Good

Remove & Replace Entire Ramp.
