Access Compliance Report

Public Rights-of-Way

(Curb Ramps)

Intersection ID: 28223	Main Street: FIELDCROFT_DR	Cross Street: WINGED_TRAIL_CT	Location: NE
ADA ID: 4FA7F5CAE823	Ramp Type: PerpDiag	Initial Pass/Fail: Fail	Overall Compliance: No
Severity Score: 8.75			
Codes/Mitigation Info/Possible Solution		Field Measurements/Component Compliance

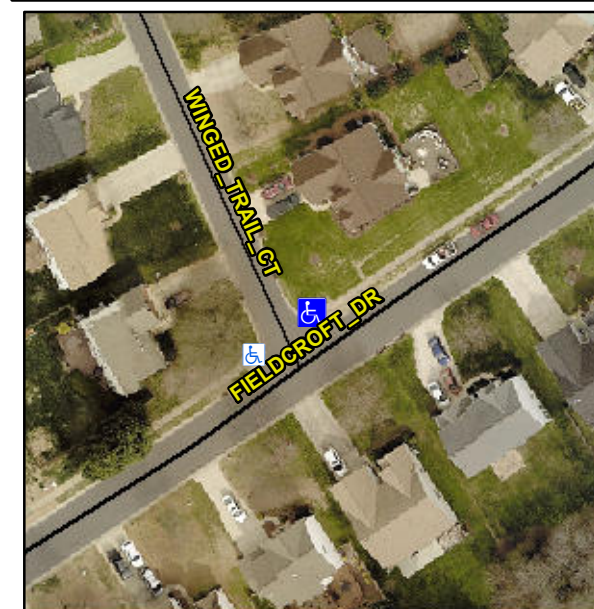
Not Found, R304.5.1

Compliance	Description	Data	Compliance	Description	Data
N/A	Ramp Length (in)	96.0	Yes	Ramp Slope (%)	5.1
No	Ramp Width (in)	45.0	Yes	Ramp XSlope (%)	0.7
N/A	Flare Type LT	N/A	N/A	Flare Type RT	N/A
N/A	Flare Slope LT (%)	N/A	N/A	Flare Slope RT (%)	N/A
N/A	Flare Traversable LT?	N/A	N/A	Flare Traversable RT?	N/A
N/A	Landing Length (in)	N/A	N/A	DWS Provided?	N/A
N/A	Landing Width (in)	N/A	N/A	DWS Contrast?	N/A
N/A	Landing Slope (%)	N/A	N/A	DWS Length (in)	N/A
N/A	Landing X Slope (%)	N/A	N/A	DWS Full Width?	N/A
N/A	Landing Curb? (Y/N)	N/A	N/A	DWS Offset (in)	N/A
N/A	Shared Landing?	N/A			
N/A	Gutter Ponding?	N/A	N/A	Gutter Slope (%)	N/A
N/A	Gutter Lip Ht (in)	N/A	N/A	Gutter X Slope (%)	N/A
N/A	Painted X Walk1?	No	N/A	Painted X Walk2?	No
	X Walk 1 Direction	To SW		X Walk 2 Direction	To SE
N/A	X Walk 1 Width (in)	N/A	N/A	X Walk 2 Width (in)	N/A
	X Walk 1 Slope (%)	1.0		X Walk 2 Slope (%)	0.6
	X Walk 1 X Slope (%)	0.0		X Walk 2 X Slope (%)	2.8

N/A	Ramp inside XWalk1?	N/A	N/A	Ramp inside XWalk2?	N/A
	Road Slope (%)	0.3	N/A	Clear Space?	N/A
	Road X Slope (%)	5.1	N/A	Clear Space to XWalk (in)	N/A
N/A	Any Obstructions?	N/A	N/A	Storm Grate/Utility Hazard?	N/A
	Obstruction Type			Storm Grate/Utility Type	
		N/A			N/A
		Yes		Surface Condition? (G/P)	Good

Remove & Replace Curb Ramp With Two New Directional Ramps or Equivalent.
