Access Compliance Report

Public Rights-of-Way

(Curb Ramps)

Intersection ID: 11306	Main Street: W_9TH_ST	Cross Street: N_SMITH_ST	Location: S
ADA ID: 4FAC4F54F76F	Ramp Type: PerpDiag	Initial Pass/Fail: Fail	Overall Compliance: No
		Severity Score: 12.5

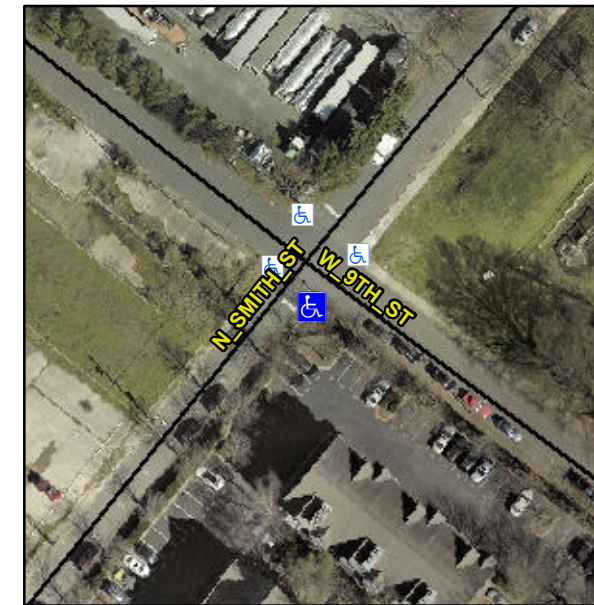
Not Found, R304.2.2

Compliance	Description	Data	Compliance	Description	Data
N/A	Ramp Length (in)	58.0	No	Ramp Slope (%)	9.8
Yes	Ramp Width (in)	72.0	Yes	Ramp XSlope (%)	0.0
N/A	Flare Type LT	N/A	N/A	Flare Type RT	N/A
N/A	Flare Slope LT (%)	N/A	N/A	Flare Slope RT (%)	N/A
N/A	Flare Traversable LT?	N/A	N/A	Flare Traversable RT?	N/A
N/A	Landing Length (in)	N/A	N/A	DWS Provided?	N/A
N/A	Landing Width (in)	N/A	N/A	DWS Contrast?	N/A
N/A	Landing Slope (%)	N/A	N/A	DWS Length (in)	N/A
N/A	Landing X Slope (%)	N/A	N/A	DWS Full Width?	N/A
N/A	Landing Curb? (Y/N)	N/A	N/A	DWS Offset (in)	N/A
N/A	Shared Landing?	N/A			
N/A	Gutter Ponding?	Yes	N/A	Gutter Slope (%)	N/A
N/A	Gutter Lip Ht (in)	N/A	N/A	Gutter X Slope (%)	N/A
N/A	Painted X Walk1?	No	N/A	Painted X Walk2?	No
	X Walk 1 Direction	To NE		X Walk 2 Direction	To NW
N/A	X Walk 1 Width (in)	N/A	N/A	X Walk 2 Width (in)	N/A
	X Walk 1 Slope (%)	1.2		X Walk 2 Slope (%)	0.3
	X Walk 1 X Slope (%)	2.3		X Walk 2 X Slope (%)	0.3

N/A	Ramp inside XWalk1?	N/A	N/A	Ramp inside XWalk2?	N/A
	Road Slope (%)	1.9	N/A	Clear Space?	N/A
	Road X Slope (%)	1.4	N/A	Clear Space to XWalk (in)	N/A
N/A	Any Obstructions?	N/A	N/A	Storm Grate/Utility Hazard?	N/A
	Obstruction Type			Storm Grate/Utility Type	
		N/A			N/A
		Yes		Surface Condition? (G/P)	Good

Remove & Replace Curb Ramp With Two New Directional Ramps or Equivalent.

Total Cost: \$ 3200.00
