Access Compliance Report

Public Rights-of-Way

(Curb Ramps)

Intersection ID: 11311	Main Street: MILTON_RD	Cross Street: N_SHARON_AMITY_RD	Location: NE
ADA ID: 4FB71B9AD06A	Ramp Type: PerpDiag	Initial Pass/Fail: Fail	Overall Compliance: No
		Severity Score: 30

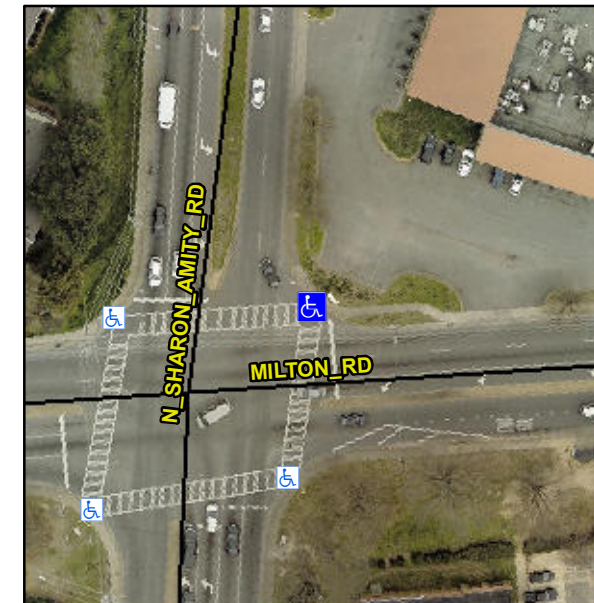
Not Found, R304.5.1, R304.2.2

Compliance	Description	Data	Compliance	Description	Data
N/A	Ramp Length (in)	59.5	No	Ramp Slope (%)	10.2
No	Ramp Width (in)	33.5	Yes	Ramp XSlope (%)	0.8
N/A	Flare Type LT	N/A	N/A	Flare Type RT	N/A
N/A	Flare Slope LT (%)	N/A	N/A	Flare Slope RT (%)	N/A
N/A	Flare Traversable LT?	N/A	N/A	Flare Traversable RT?	N/A
N/A	Landing Length (in)	N/A	N/A	DWS Provided?	N/A
N/A	Landing Width (in)	N/A	N/A	DWS Contrast?	N/A
N/A	Landing Slope (%)	N/A	N/A	DWS Length (in)	N/A
N/A	Landing X Slope (%)	N/A	N/A	DWS Full Width?	N/A
N/A	Landing Curb? (Y/N)	N/A	N/A	DWS Offset (in)	N/A
N/A	Shared Landing?	N/A			
N/A	Gutter Ponding?	N/A	N/A	Gutter Slope (%)	N/A
N/A	Gutter Lip Ht (in)	N/A	N/A	Gutter X Slope (%)	N/A
N/A	Painted X Walk1?	Yes	N/A	Painted X Walk2?	Yes
	X Walk 1 Direction	To W		X Walk 2 Direction	To S
N/A	X Walk 1 Width (in)	122.5	N/A	X Walk 2 Width (in)	116.5
	X Walk 1 Slope (%)	2.5		X Walk 2 Slope (%)	0.6
	X Walk 1 X Slope (%)	0.2		X Walk 2 X Slope (%)	1.6

N/A	Ramp inside XWalk1?	Yes	N/A	Ramp inside XWalk2?	Yes
	Road Slope (%)	2.3	N/A	Clear Space?	N/A
	Road X Slope (%)	3.8	N/A	Clear Space to XWalk (in)	N/A
N/A	Any Obstructions?	N/A	N/A	Storm Grate/Utility Hazard?	N/A
	Obstruction Type			Storm Grate/Utility Type	
		N/A			N/A
		Yes		Surface Condition? (G/P)	Good

Remove & Replace Curb Ramp With Two New Directional Ramps or Equivalent.
