Access Compliance Report

Public Rights-of-Way

(Curb Ramps)

Intersection ID: 17774	Main Street: CROYDON_RD	Cross Street: HILLSIDE_AV	Location: NW
ADA ID: 4FC275CE5332	Ramp Type: BlendTrans1	Initial Pass/Fail: Fail	Overall Compliance: No
		Severity Score: 12.5

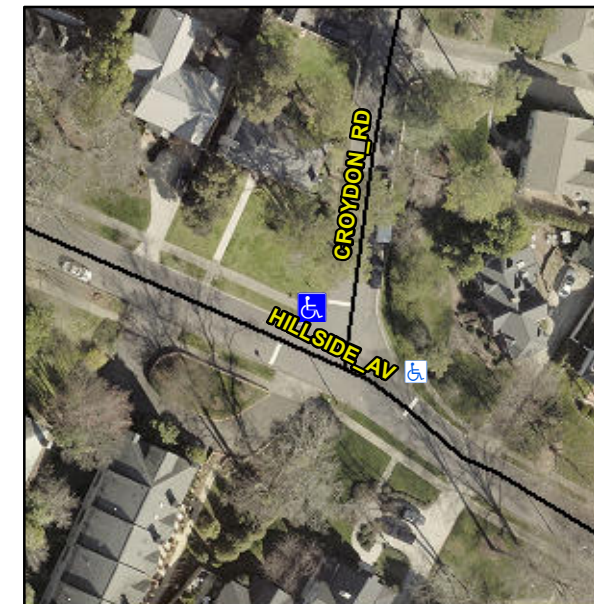
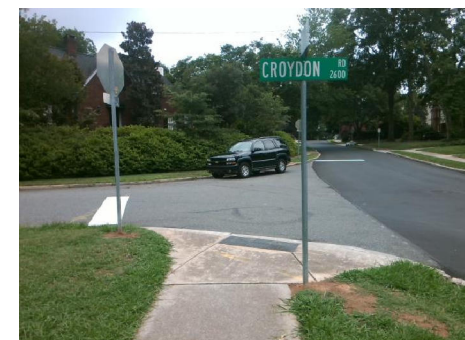
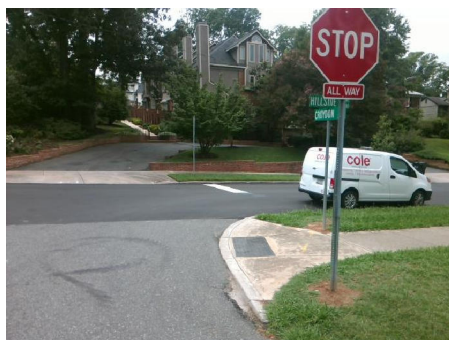
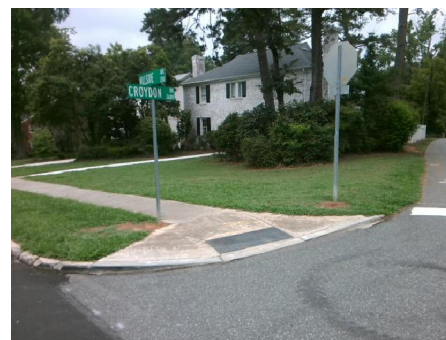
Compliance	Description	Data	Compliance	Description	Data
N/A	Ramp Length (in)	27.0	Yes	BlendTrans Slope (%)	2.1
Yes	Ramp Width (in)	48.0	No	BlendTrans XSlope (%)	5.1
N/A	Flare Type LT	N/A	N/A	Flare Type RT	N/A
N/A	Flare Slope LT (%)	N/A	N/A	Flare Slope RT (%)	N/A
N/A	Flare Traversable LT?	N/A	N/A	Flare Traversable RT?	N/A
N/A	Landing Length (in)	N/A	N/A	DWS Provided?	N/A
N/A	Landing Width (in)	N/A	N/A	DWS Contrast?	N/A
N/A	Landing Slope (%)	N/A	N/A	DWS Length (in)	N/A
N/A	Landing X Slope (%)	N/A	N/A	DWS Full Width?	N/A
N/A	Landing Curb? (Y/N)	N/A	N/A	DWS Offset (in)	N/A
N/A	Shared Landing?	N/A			
N/A	Gutter Ponding?	N/A	N/A	Gutter Slope (%)	N/A
N/A	Gutter Lip Ht (in)	1.0	N/A	Gutter X Slope (%)	N/A
N/A	Painted X Walk1?	No	N/A	Painted X Walk2?	No
	X Walk 1 Direction	To S		X Walk 2 Direction	To SE
	X Walk 1 Width (in)	N/A		X Walk 2 Width (in)	N/A
	X Walk 1 Slope (%)	3.2		X Walk 2 Slope (%)	7.4
	X Walk 1 X Slope (%)	8.3		X Walk 2 X Slope (%)	0.5

N/A	Ramp inside XWalk1?	N/A	N/A	Ramp inside XWalk2?	N/A
	Road Slope (%)	3.8		Clear Space?	N/A
	Road X Slope (%)	6.8	N/A	Clear Space to XWalk (in)	N/A
N/A	Any Obstructions?	N/A	N/A	Storm Grate/Utility Hazard?	N/A
	Obstruction Type			Storm Grate/Utility Type	
		N/A			N/A
			Yes	Surface Condition? (G/P)	Good
			N/A	Curb Slope (%)	2.0

Remove & Replace Curb Ramp With Two New Directional Ramps or Equivalent.

R304.5.3
