Access Compliance Report

Public Rights-of-Way

(Curb Ramps)

Intersection ID: 53972	Main Street: SHOPTON_RD_WEST	Cross Street: CADEN_RD	Location: NE
ADA ID: 4FC47616F159	Ramp Type: Perp	Initial Pass/Fail: Fail	Overall Compliance: No
Severity Score: 25			
Codes/Mitigation Info/Possible Solution		Field Measurements/Component Compliance

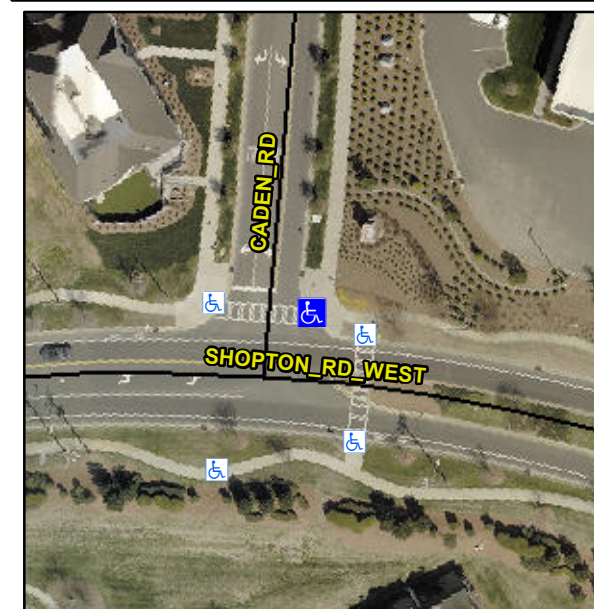
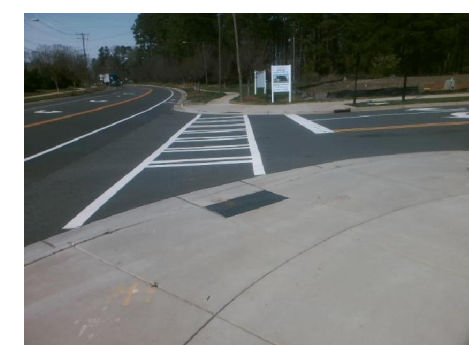
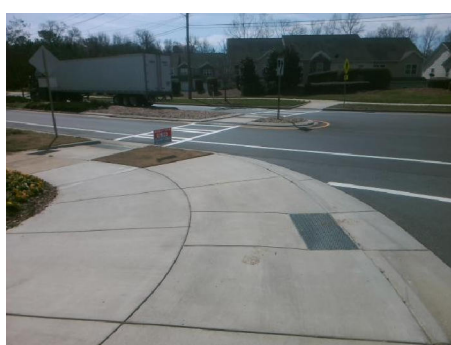
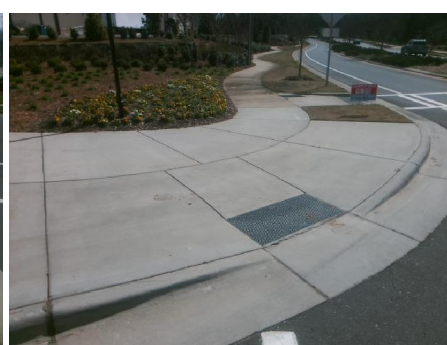
R304.2.2, R304.5.3

Compliance	Description	Data	Compliance	Description	Data
N/A	Ramp Length (in)	82.0	No	Ramp Slope (%)	11.4
Yes	Ramp Width (in)	48.0	No	Ramp XSlope (%)	5.6
N/A	Flare Type LT	N/A	N/A	Flare Type RT	N/A
N/A	Flare Slope LT (%)	N/A	N/A	Flare Slope RT (%)	N/A
N/A	Flare Traversable LT?	N/A	N/A	Flare Traversable RT?	N/A
N/A	Landing Length (in)	N/A	N/A	DWS Provided?	N/A
N/A	Landing Width (in)	N/A	N/A	DWS Contrast?	N/A
N/A	Landing Slope (%)	N/A	N/A	DWS Length (in)	N/A
N/A	Landing X Slope (%)	N/A	N/A	DWS Full Width?	N/A
N/A	Landing Curb? (Y/N)	N/A	N/A	DWS Offset (in)	N/A
N/A	Shared Landing?	N/A			
N/A	Gutter Ponding?	N/A	N/A	Gutter Slope (%)	N/A
N/A	Gutter Lip Ht (in)	N/A	N/A	Gutter X Slope (%)	N/A
N/A	Painted X Walk1?	Yes	N/A	Painted X Walk2?	N/A
	X Walk 1 Direction	To NW		X Walk 2 Direction	N/A
N/A	X Walk 1 Width (in)	96.0	N/A	X Walk 2 Width (in)	N/A
	X Walk 1 Slope (%)	1.0		X Walk 2 Slope (%)	N/A
	X Walk 1 X Slope (%)	0.5		X Walk 2 X Slope (%)	N/A

N/A	Ramp inside XWalk1?	Yes	N/A	Ramp inside XWalk2?	N/A
	Road Slope (%)	N/A	N/A	Clear Space?	N/A
	Road X Slope (%)	N/A	N/A	Clear Space to XWalk (in)	N/A
N/A	Any Obstructions?	N/A	N/A	Storm Grate/Utility Hazard?	N/A
	Obstruction Type			Storm Grate/Utility Type	
		N/A			N/A
			Yes	Surface Condition? (G/P)	Good

Remove & Replace Entire Ramp.
