Access Compliance Report

Public Rights-of-Way

(Curb Ramps)

Intersection ID: 27628	Main Street: BALLANTYNE COMMONS PY	Cross Street: ADAIR MANOR CT	Location: NE
ADA ID: 4FC7266CFB0D	Ramp Type: Perp	Initial Pass/Fail: Fail	Overall Compliance: No
Severity Score: 8.75			
Codes/Mitigation Info/Possible Solution		Field Measurements/Component Compliance

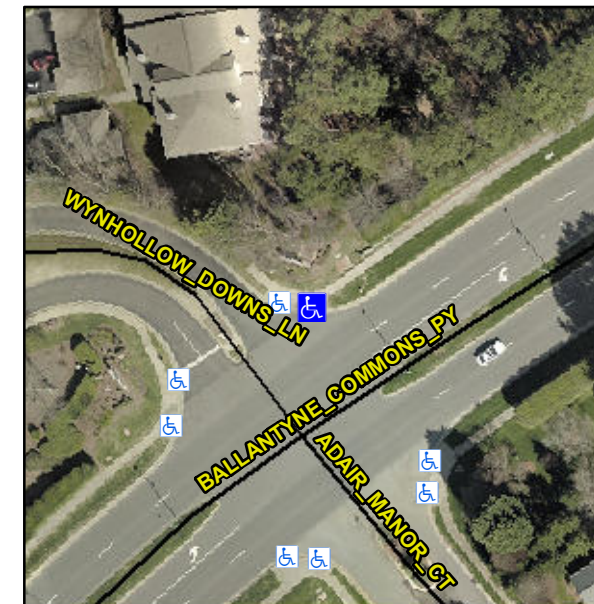
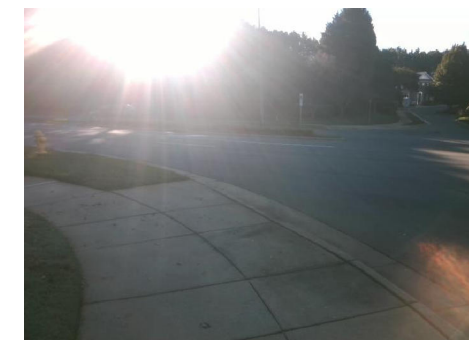
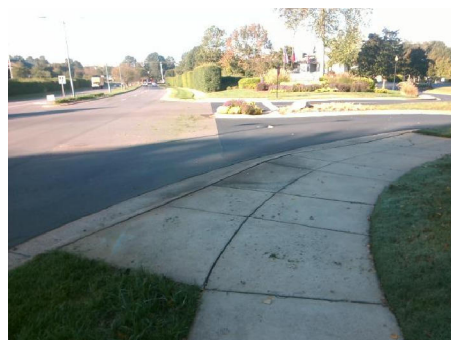
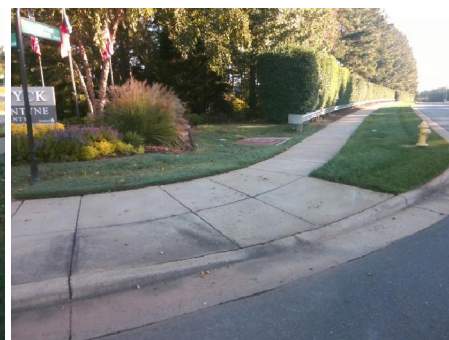
Not Found, R304.5.1

Compliance	Description	Data	Compliance	Description	Data
N/A	Ramp Length (in)	113.0	Yes	Ramp Slope (%)	5.7
No	Ramp Width (in)	40.5	Yes	Ramp XSlope (%)	1.9
N/A	Flare Type LT	N/A	N/A	Flare Type RT	N/A
N/A	Flare Slope LT (%)	N/A	N/A	Flare Slope RT (%)	N/A
N/A	Flare Traversable LT?	N/A	N/A	Flare Traversable RT?	N/A
N/A	Landing Length (in)	N/A	N/A	DWS Provided?	N/A
N/A	Landing Width (in)	N/A	N/A	DWS Contrast?	N/A
N/A	Landing Slope (%)	N/A	N/A	DWS Length (in)	N/A
N/A	Landing X Slope (%)	N/A	N/A	DWS Full Width?	N/A
N/A	Landing Curb? (Y/N)	N/A	N/A	DWS Offset (in)	N/A
N/A	Shared Landing?	N/A			
N/A	Gutter Ponding?	N/A	N/A	Gutter Slope (%)	N/A
N/A	Gutter Lip Ht (in)	N/A	N/A	Gutter X Slope (%)	N/A
N/A	Painted X Walk1?	No	N/A	Painted X Walk2?	N/A
	X Walk 1 Direction	To SE		X Walk 2 Direction	N/A
N/A	X Walk 1 Width (in)	N/A	N/A	X Walk 2 Width (in)	N/A
	X Walk 1 Slope (%)	2.4		X Walk 2 Slope (%)	N/A
	X Walk 1 X Slope (%)	1.9		X Walk 2 X Slope (%)	N/A

N/A	Ramp inside XWalk1?	N/A	N/A	Ramp inside XWalk2?	N/A
	Road Slope (%)	N/A	N/A	Clear Space?	N/A
	Road X Slope (%)	N/A	N/A	Clear Space to XWalk (in)	N/A
N/A	Any Obstructions?	N/A	N/A	Storm Grate/Utility Hazard?	N/A
	Obstruction Type			Storm Grate/Utility Type	
		N/A			N/A
			Yes	Surface Condition? (G/P)	Good

Remove & Replace Entire Ramp.
