# Access Compliance Report

## Public Rights-of-Way

| Intersection ID: 10022918 | Main Street: CEDAR_CROFT_DR | Cross Street: N/A | Location: S |
| ADA ID: 4FC9F15B6381 | Ramp Type: BlendTrans2 | Initial Pass/Fail: Pass | Overall Compliance: No |

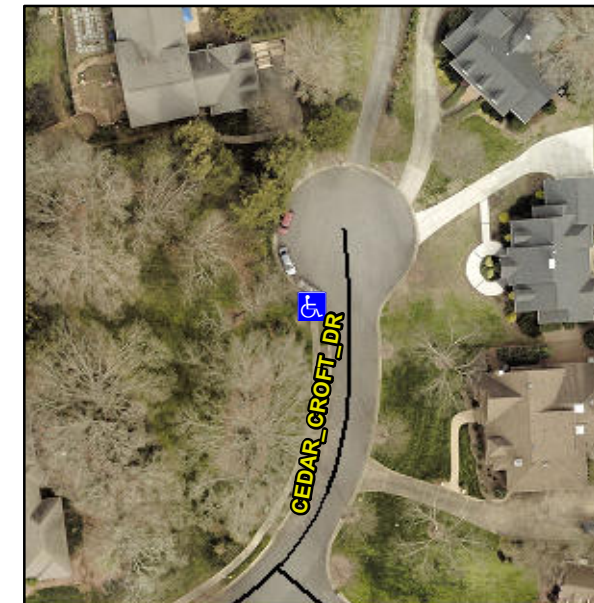
**ASP LIP 0.5**

**Not Found, R304.5.3, R304.2.3**

| Compliance | Description | Data | Compliance | Description | Data |
|---|---|---|---|---|---|
| Yes | Ramp Width (in) | 48.0 | No | BlendTrans XSlope (%) | 2.4 |
| No | Flare Slope LT (%) | N/A | N/A | Flare Slope RT (%) | N/A |
| | | | No | Curb Slope (%) | 14.2 |

**Remove & Replace Curb Ramp With Two New Directional Ramps or Equivalent.**

Total Cost: \$ 3200.00
