Access Compliance Report Public Rights-of-Way (Curb Ramps)

Intersection ID: N/A Main Street: E_7TH_ST Cross Street: N/A Location: E

ADA ID: 4FCC419AD6F5 Ramp Type: Perp Initial Pass/Fail: Fail Overall Compliance: No Severity Score: 13.75

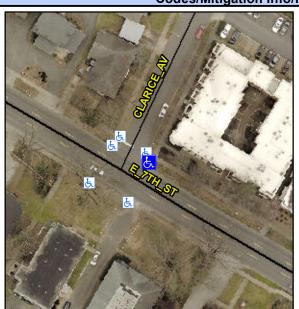
Field Measurements/Component Compliance							
	Comp	liance Description	Data	Comp	liance Description	Data	
	N/A	Ramp Length (in)	76.0	No	Ramp Slope (%)	10.2	
	Yes	Ramp Width (in)	48.0	No	Ramp XSlope (%)	3.0	
	N/A	Flare Type LT	N/A	N/A	Flare Type RT	N/A	
	N/A	Flare Slope LT (%)	N/A	N/A	Flare Slope RT (%)	N/A	
	N/A	Flare Traversable LT?	N/A	N/A	Flare Traversable RT?	N/A	
	N/A	Landing Length (in)	N/A	N/A	DWS Provided?	N/A	
	N/A	Landing Width (in)	N/A	N/A	DWS Contrast?	N/A	
	N/A	Landing Slope (%)	N/A	N/A	DWS Length (in)	N/A	
	N/A	Landing X Slope (%)	N/A	N/A	DWS Full Width?	N/A	
	N/A	Landing Curb? (Y/N)	N/A	N/A	DWS Offset (in)	N/A	
	N/A	Shared Landing?	N/A				
	N/A	Gutter Ponding?	N/A	N/A	Gutter Slope (%)	N/A	
	N/A	Gutter Lip Ht (in)	N/A	N/A	Gutter X Slope (%)	N/A	
	N/A	Painted X Walk1?	No	N/A	Painted X Walk2?	N/A	
		X Walk 1 Direction	To SW		X Walk 2 Direction	N/A	
	N/A	X Walk 1 Width (in)	N/A	N/A	X Walk 2 Width (in)	N/A

X Walk 1 Slope (%)	4.7		X Walk 2 Slope (%)	N/A	
		X Walk 1 X Slope (%)	2.6		X Walk 2 X Slope (%)	N/A	
	N/A	Ramp inside XWalk1?	N/A	N/A	Ramp inside XWalk2?	N/A	
		Road Slope (%)	N/A	N/A	Clear Space?	N/A	
		Road X Slope (%)	N/A	N/A	Clear Space to XWalk (in)	N/A	
	N/A	Any Obstructions?	N/A	N/A	Storm Grate/Utility Hazard?	N/A	
		Obstruction Type			Storm Grate/Utility Type		
			N/A			N/A	
				Yes	Surface Condition? (G/P)	Good	
100	A SECTION OF	ACTION ACTIONS

Possible Solutions:							
Remove & Replace Entire Ramp.							
·							
Surveyor Notes:							
N/A							
PROW/ADA:							
Not Found, R304.2.2, R304.5.3							
,,,
