Access Compliance Report Public Rights-of-Way (Curb Ramps)

Intersection ID: 13793 Main Street: CLEMENT AV Cross Street: E 8TH ST Location:

ADA ID: 4FD8BA69DCDD Ramp Type: PerpDiag Initial Pass/Fail: Fail **Overall Compliance: No** Severity Score: 21.25

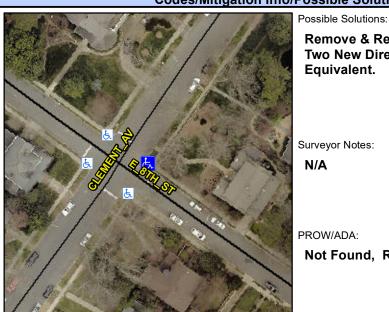
Compliance Description			Data	Compli	Data	
	N/A	Ramp Length (in)	42.5	No	Ramp Slope (%)	9.4
	No	Ramp Width (in)	47.0	Yes	Ramp XSlope (%)	1.1
	N/A	Flare Type LT	N/A	N/A	Flare Type RT	N/A
	N/A	Flare Slope LT (%)	N/A	N/A	Flare Slope RT (%)	N/A
	N/A	Flare Traversable LT?	N/A	N/A	Flare Traversable RT?	N/A
	N/A	Landing Length (in)	N/A	N/A	DWS Provided?	N/A
	N/A	Landing Width (in)	N/A	N/A	DWS Contrast?	N/A
	N/A	Landing Slope (%)	N/A	N/A	DWS Length (in)	N/A
	N/A	Landing X Slope (%)	N/A	N/A	DWS Full Width?	N/A
	N/A	Landing Curb? (Y/N)	N/A	N/A	DWS Offset (in)	N/A
	N/A	Shared Landing?	N/A			
	N/A	Gutter Ponding?	N/A	N/A	Gutter Slope (%)	N/A
	N/A	Gutter Lip Ht (in)	N/A	N/A	Gutter X Slope (%)	N/A
	N/A	Painted X Walk1?	No	N/A	Painted X Walk2?	No
		X Walk 1 Direction	To NW		X Walk 2 Direction	To SW
	N/A	X Walk 1 Width (in)	N/A	N/A	X Walk 2 Width (in)	N/A
		X Walk 1 Slope (%)	3.1		X Walk 2 Slope (%)	0.3
		X Walk 1 X Slope (%)	0.6		X Walk 2 X Slope (%)	1.3

N/A	Ramp inside XWalk1?	N/A	N/A	Ramp inside XWalk2?	N/A
		Road Slope (%)	0.5	N/A	Clear Space?	N/A
		Road X Slope (%)	1.1	N/A	Clear Space to XWalk (in)	N/A
	N/A	Any Obstructions?	N/A	N/A	Storm Grate/Utility Hazard?	N/A
		Obstruction Type		l	Storm Grate/Utility Type	
			N/A	l		N/A

CLEMENT AV Street 1 Name Stop Condition-Street 2 StopSign Street 2 Name E8THST Stop Condition-Street 1 StopSign Remove & Replace Curb Ramp With Two New Directional Ra Equivalent.

Not Found, R304.5.1, F

rb Ramp With	N
amps or	N
	N
	N
	N
	N
	N
	N
	N
	N
	N
₹304.2.2	N
	N
	N
	N
	N
	N

Total Cost: 3200.00
