Access Compliance Report

Public Rights-of-Way

(Curb Ramps)

| Intersection ID: 10022801 | Main Street: CASCADE_POINTE_BV | Cross Street: N/A | Location: SW |

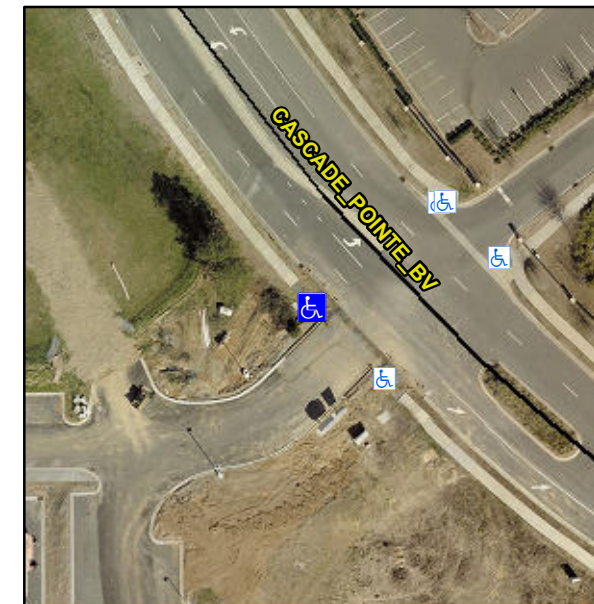
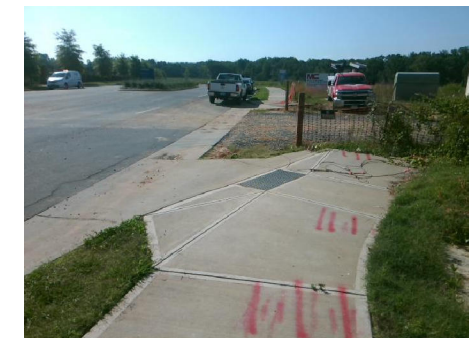
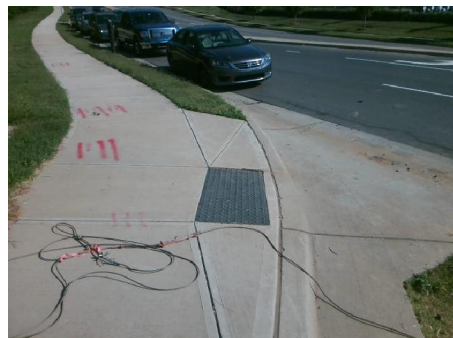
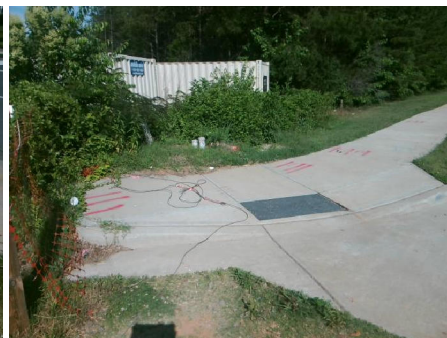
| ADA ID: 4FDD7DDF293F | Ramp Type: Combination1Diag | Initial Pass/Fail: Fail | Overall Compliance: No |

CONSTRUCTION, RT RP < 5%

R304.3.2

| Compliance | Description | Data | Compliance | Description | Data |
|---|---|---|---|---|---|
| No | Ramp Slope LT (%) | 9.5 | Yes | Ramp Slope RT (%) | 2.8 |

Remove & Replace Curb Ramp With Two New Directional Ramps or Equivalent.
