Access Compliance Report

Public Rights-of-Way

(Curb Ramps)

Intersection ID: 42779	Main Street: SILVERSWORD_DR	Cross Street: RED_VULCAN_CT	Location: E
ADA ID: 4FDF89CF470F	Ramp Type: Perp	Initial Pass/Fail: Fail	Overall Compliance: No
Severity Score: 22.5			
Codes/Mitigation Info/Possible Solution		Field Measurements/Component Compliance

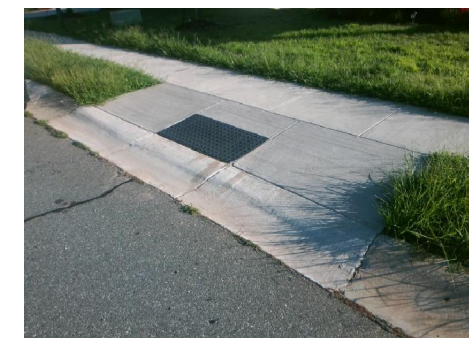
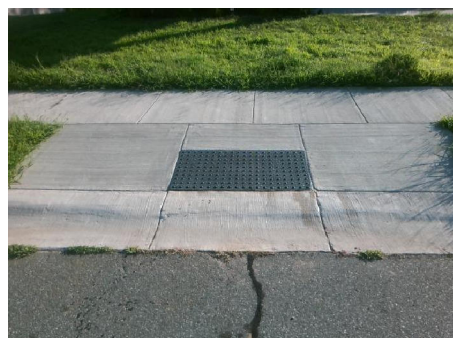
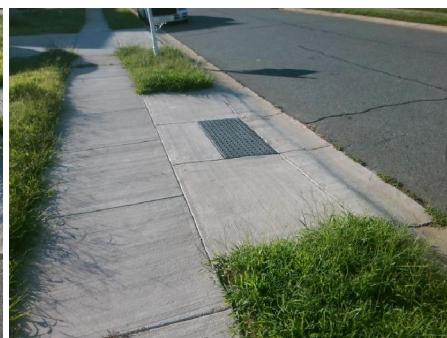
Not Found, R304.5.1, R304.2.2, R304.5.3

Compliance	Description	Data	Compliance	Description	Data
N/A	Ramp Length (in)	46.5	No	Ramp Slope (%)	10.4
No	Ramp Width (in)	47.5	No	Ramp XSlope (%)	3.6
N/A	Flare Type LT	N/A	N/A	Flare Type RT	N/A
N/A	Flare Slope LT (%)	N/A	N/A	Flare Slope RT (%)	N/A
N/A	Flare Traversable LT?	N/A	N/A	Flare Traversable RT?	N/A
N/A	Landing Length (in)	N/A	N/A	DWS Provided?	N/A
N/A	Landing Width (in)	N/A	N/A	DWS Contrast?	N/A
N/A	Landing Slope (%)	N/A	N/A	DWS Length (in)	N/A
N/A	Landing X Slope (%)	N/A	N/A	DWS Full Width?	N/A
N/A	Landing Curb? (Y/N)	N/A	N/A	DWS Offset (in)	N/A
N/A	Shared Landing?	N/A			
N/A	Gutter Ponding?	N/A	N/A	Gutter Slope (%)	N/A
N/A	Gutter Lip Ht (in)	N/A	N/A	Gutter X Slope (%)	N/A
N/A	Painted X Walk1?	No	N/A	Painted X Walk2?	N/A
	X Walk 1 Direction	To S		X Walk 2 Direction	N/A
N/A	X Walk 1 Width (in)	N/A	N/A	X Walk 2 Width (in)	N/A
	X Walk 1 Slope (%)	3.1		X Walk 2 Slope (%)	N/A
	X Walk 1 X Slope (%)	1.5		X Walk 2 X Slope (%)	N/A

N/A	Ramp inside XWalk1?	N/A	N/A	Ramp inside XWalk2?	N/A
	Road Slope (%)	N/A	N/A	Clear Space?	N/A
	Road X Slope (%)	N/A	N/A	Clear Space to XWalk (in)	N/A
N/A	Any Obstructions?	N/A	N/A	Storm Grate/Utility Hazard?	N/A
	Obstruction Type			Storm Grate/Utility Type	
		N/A			N/A
			Yes	Surface Condition? (G/P)	Good

Possible Solutions:

Remove & Replace Entire Ramp.
