Access Compliance Report Public Rights-of-Way (Curb Ramps)

Intersection ID: 29158 Main Street: RIDGE_RD Cross Street: HIGHLAND_PARK_DR Location: E

ADA ID: 4FE4D8D57B01 Ramp Type: Perp Initial Pass/Fail: Fail Overall Compliance: No Severity Score: 8.75

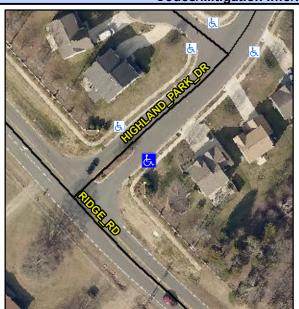
Fleid Measurements/Component Compilance					
Compliance Description		Data	Compliance Description		Data
N/A	Ramp Length (in)	49.5	Yes	Ramp Slope (%)	6.4
No	Ramp Width (in)	47.0	Yes	Ramp XSlope (%)	0.8
N/A	Flare Type LT	N/A	N/A	Flare Type RT	N/A
N/A	Flare Slope LT (%)	N/A	N/A	Flare Slope RT (%)	N/A
N/A	Flare Traversable LT?	N/A	N/A	Flare Traversable RT?	N/A
N/A	Landing Length (in)	N/A	N/A	DWS Provided?	N/A
N/A	Landing Width (in)	N/A	N/A	DWS Contrast?	N/A
N/A	Landing Slope (%)	N/A	N/A	DWS Length (in)	N/A
N/A	Landing X Slope (%)	N/A	N/A	DWS Full Width?	N/A
N/A	Landing Curb? (Y/N)	N/A	N/A	DWS Offset (in)	N/A
N/A	Shared Landing?	N/A			
N/A	Gutter Ponding?	N/A	N/A	Gutter Slope (%)	N/A
N/A	Gutter Lip Ht (in)	N/A	N/A	Gutter X Slope (%)	N/A
N/A	Painted X Walk1?	No	N/A	Painted X Walk2?	N/A
	X Walk 1 Direction	To NW		X Walk 2 Direction	N/A
N/A	X Walk 1 Width (in)	N/A	N/A	X Walk 2 Width (in)	N/A
	X Walk 1 Slope (%)	3.3		X Walk 2 Slope (%)	N/A

X Walk 1 X Slope (%)	1.5		X Walk 2 X Slope (%)	N/A
N/A	Ramp inside XWalk1?	N/A	N/A	Ramp inside XWalk2?	N/A
	Road Slope (%)	N/A	N/A	Clear Space?	N/A
	Road X Slope (%)	N/A	N/A	Clear Space to XWalk (in)	N/A
N/A	Any Obstructions?	N/A	N/A	Storm Grate/Utility Hazard?	N/A
	Obstruction Type			Storm Grate/Utility Type

Remove & Replace Entire Ramp.

PROW/ADA:
R304.5.1
