## **Access Compliance Report Public Rights-of-Way** (Curb Ramps)

Intersection ID: 7284 Main Street: TOM\_HUNTER\_RD **Cross Street: VANCOUVER DR** Location: SW ADA ID: 4FF1237D952C Ramp Type: BlendTrans1 Initial Pass/Fail: Fail **Overall Compliance: No Severity Score:** 8.75

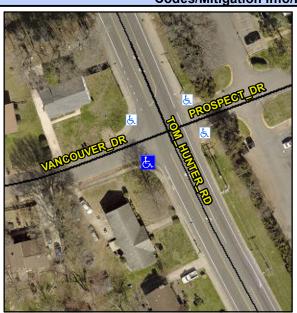
Fleid Measurements/Component Compliance					
Compliance Description		Data	Compliance Description		Data
N/A	Ramp Length (in)	49.0	Yes	BlendTrans Slope (%)	4.0
No	Ramp Width (in)	43.0	Yes	BlendTrans XSlope (%)	0.4
N/A	Flare Type LT	N/A	N/A	Flare Type RT	N/A
N/A	Flare Slope LT (%)	N/A	N/A	Flare Slope RT (%)	N/A
N/A	Flare Traversable LT?	N/A	N/A	Flare Traversable RT?	N/A
N/A	Landing Length (in)	N/A	N/A	DWS Provided?	N/A
N/A	Landing Width (in)	N/A	N/A	DWS Contrast?	N/A
N/A	Landing Slope (%)	N/A	N/A	DWS Length (in)	N/A
N/A	Landing X Slope (%)	N/A	N/A	DWS Full Width?	N/A
N/A	Landing Curb? (Y/N)	N/A	N/A	DWS Offset (in)	N/A
N/A	Shared Landing?	N/A			
N/A	Gutter Ponding?	N/A	N/A	Gutter Slope (%)	N/A
N/A	Gutter Lip Ht (in)	N/A	N/A	Gutter X Slope (%)	N/A
N/A	Painted X Walk1?	No	N/A	Painted X Walk2?	No
	X Walk 1 Direction	To NE		X Walk 2 Direction	To NW
	X Walk 1 Width (in)	N/A		X Walk 2 Width (in)	N/A
	X Walk 1 Slope (%)	3.4		X Walk 2 Slope (%)	1.1

X Walk 1 X Slope (%)	0.7		X Walk 2 X Slope (%)	1.9
N/A	Ramp inside XWalk1?	N/A	N/A	Ramp inside XWalk2?	N/A
	Road Slope (%)	0.9		Clear Space?	N/A
	Road X Slope (%)	3.3	N/A	Clear Space to XWalk (in)	N/A
N/A	Any Obstructions?	N/A	N/A	Storm Grate/Utility Hazard?	N/A
	Obstruction Type			Storm Grate/Utility Type

Possible Solutions: Remove & Replace Curb Ramp With Two New Directional Ramps or Equivalent. Surveyor Notes: N/A PROW/ADA: Not Found, R304.5.1
