Access Compliance Report

Public Rights-of-Way

(Curb Ramps)

Intersection ID: 3497	Main Street: SAWGRASS RIDGE PL	Cross Street: TRADITION VIEW DR	Location: SW
ADA ID: 4FF494D4D1ED	Ramp Type: Perp	Initial Pass/Fail: Fail	Overall Compliance: No
Severity Score: 10			
Codes/Mitigation Info/Possible Solution		Field Measurements/Component Compliance

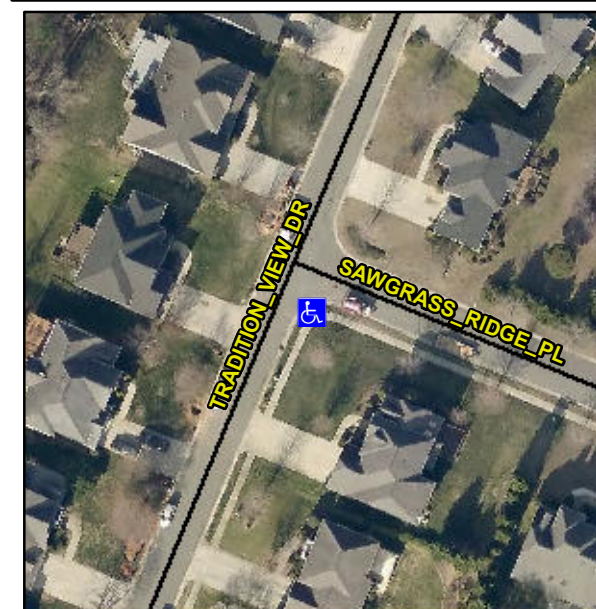
R304.5.1, R304.5.3

Compliance	Description	Data	Compliance	Description	Data
N/A	Ramp Length (in)	51.0	Yes	Ramp Slope (%)	5.0
No	Ramp Width (in)	43.0	No	Ramp XSlope (%)	2.4
N/A	Flare Type LT	N/A	N/A	Flare Type RT	N/A
N/A	Flare Slope LT (%)	N/A	N/A	Flare Slope RT (%)	N/A
N/A	Flare Traversable LT?	N/A	N/A	Flare Traversable RT?	N/A
N/A	Landing Length (in)	N/A	N/A	DWS Provided?	N/A
N/A	Landing Width (in)	N/A	N/A	DWS Contrast?	N/A
N/A	Landing Slope (%)	N/A	N/A	DWS Length (in)	N/A
N/A	Landing X Slope (%)	N/A	N/A	DWS Full Width?	N/A
N/A	Landing Curb? (Y/N)	N/A	N/A	DWS Offset (in)	N/A
N/A	Shared Landing?	N/A			
N/A	Gutter Ponding?	N/A	N/A	Gutter Slope (%)	N/A
N/A	Gutter Lip Ht (in)	1.0	N/A	Gutter X Slope (%)	N/A
N/A	Painted X Walk1?	No	N/A	Painted X Walk2?	N/A
	X Walk 1 Direction	To NE		X Walk 2 Direction	N/A
N/A	X Walk 1 Width (in)	N/A	N/A	X Walk 2 Width (in)	N/A
	X Walk 1 Slope (%)	N/A		X Walk 2 Slope (%)	N/A
	X Walk 1 X Slope (%)	N/A		X Walk 2 X Slope (%)	N/A

N/A	Ramp inside XWalk1?	N/A	N/A	Ramp inside XWalk2?	N/A
	Road Slope (%)	N/A	N/A	Clear Space?	N/A
	Road X Slope (%)	N/A	N/A	Clear Space to XWalk (in)	N/A
N/A	Any Obstructions?	N/A	N/A	Storm Grate/Utility Hazard?	N/A
	Obstruction Type			Storm Grate/Utility Type	
		N/A			N/A
		Yes		Surface Condition? (G/P)	Good

Possible Solutions:

Remove & Replace Entire Ramp.
