# Access Compliance Report

## Public Rights-of-Way

### (Curb Ramps)

| Intersection ID: 13189 | Main Street: HAWTHORNE_LN | Cross Street: SUNNYSIDE_AV | Location: | NE |

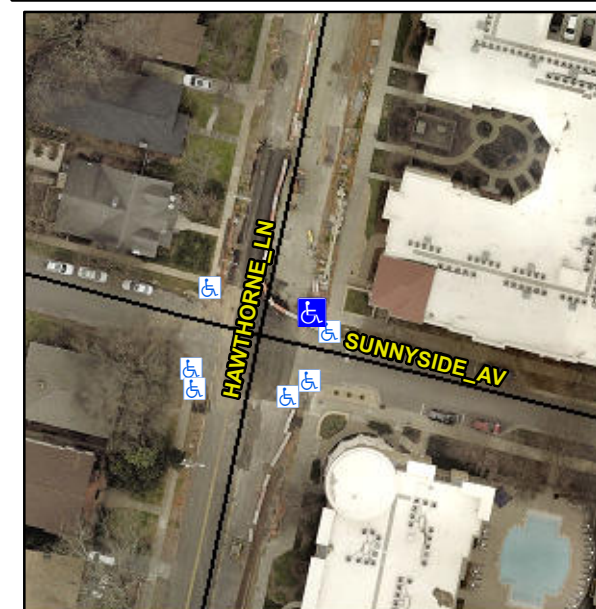
| ADA ID: 4FF777310B04 | Ramp Type: Directional1 | Initial Pass/Fail: Pass | Overall Compliance: No | Severity Score: 2.5 |

**R304.2.2-Perp, R304.3.2-Para, R305.1.4**

| Compliance | Description | Data | Compliance | Description | Data |
|---|---|---|---|---|---|
| No | Landing Slope (%) | 2.2 | Yes | DWS Length (in) | 24.0 |
| Yes | Landing X Slope (%) | 1.8 | No | DWS Full Width? | No |

**Remove & Replace Entire Ramp.**

Total Cost: \$ 1600.00
