# Access Compliance Report

## Public Rights-of-Way

### (Curb Ramps)

Intersection ID: 10024054	Main Street: CORONATION_BV	Cross Street: N/A	Location: SE
ADA ID: 5007E2257D34	Ramp Type: Perp	Initial Pass/Fail: Fail	Overall Compliance: No
Severity Score: 26.25			
Codes/Mitigation Info/Possible Solution		Field Measurements/Component Compliance

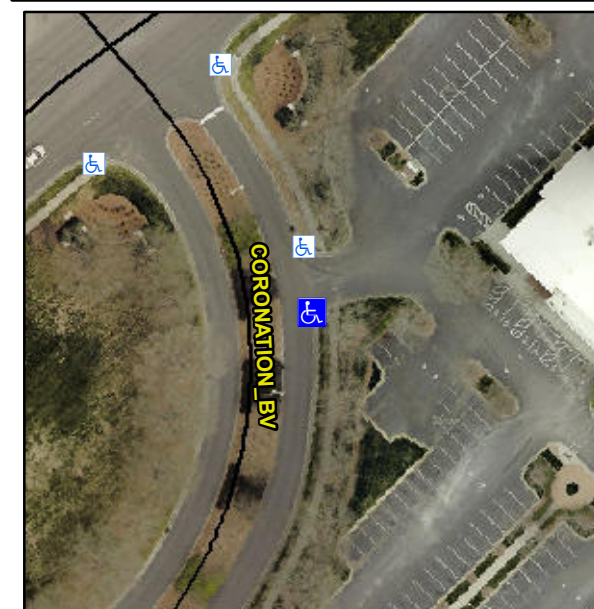
**Not Found, R304.2.2**

Compliance	Description	Data	Compliance	Description	Data
N/A	Ramp Length (in)	83.0	No	Ramp Slope (%)	12.9
Yes	Ramp Width (in)	48.0	Yes	Ramp XSlope (%)	3.9
N/A	Flare Type LT	N/A	N/A	Flare Type RT	N/A
N/A	Flare Slope LT (%)	N/A	N/A	Flare Slope RT (%)	N/A
N/A	Flare Traversable LT?	N/A	N/A	Flare Traversable RT?	N/A
N/A	Landing Length (in)	N/A	N/A	DWS Provided?	N/A
N/A	Landing Width (in)	N/A	N/A	DWS Contrast?	N/A
N/A	Landing Slope (%)	N/A	N/A	DWS Length (in)	N/A
N/A	Landing X Slope (%)	N/A	N/A	DWS Full Width?	N/A
N/A	Landing Curb? (Y/N)	N/A	N/A	DWS Offset (in)	N/A
N/A	Shared Landing?	N/A			
N/A	Gutter Ponding?	N/A	N/A	Gutter Slope (%)	N/A
N/A	Gutter Lip Ht (in)	N/A	N/A	Gutter X Slope (%)	N/A
N/A	Painted X Walk1?	No	N/A	Painted X Walk2?	N/A
	X Walk 1 Direction	To N		X Walk 2 Direction	N/A
N/A	X Walk 1 Width (in)	N/A	N/A	X Walk 2 Width (in)	N/A
	X Walk 1 Slope (%)	0.6		X Walk 2 Slope (%)	N/A
	X Walk 1 X Slope (%)	4.6		X Walk 2 X Slope (%)	N/A

N/A	Ramp inside XWalk1?	N/A	N/A	Ramp inside XWalk2?	N/A
	Road Slope (%)	N/A	N/A	Clear Space?	N/A
	Road X Slope (%)	N/A	N/A	Clear Space to XWalk (in)	N/A
N/A	Any Obstructions?	N/A	N/A	Storm Grate/Utility Hazard?	N/A
	Obstruction Type			Storm Grate/Utility Type	
		N/A			N/A
			Yes	Surface Condition? (G/P)	Good

**Remove & Replace Entire Ramp.**
