Intersection ID: 11471	Main Street: GRACE_ST	Cross Street: UMSTEAD_ST	Location:	NW
ADA ID: 500A4AAFEE1A	Ramp Type: Perp	Initial Pass/Fail: Fail	Overall Compliance: No	Severity Score: 13.75

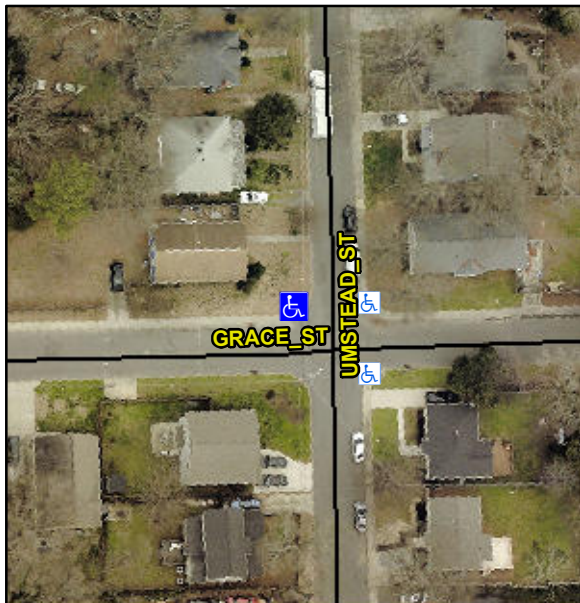
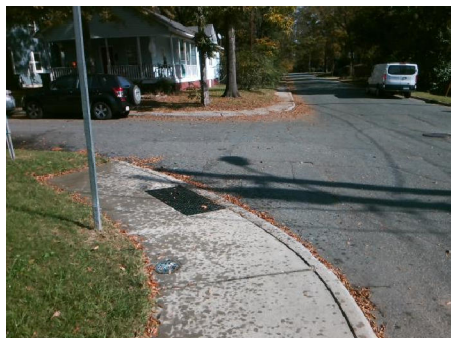
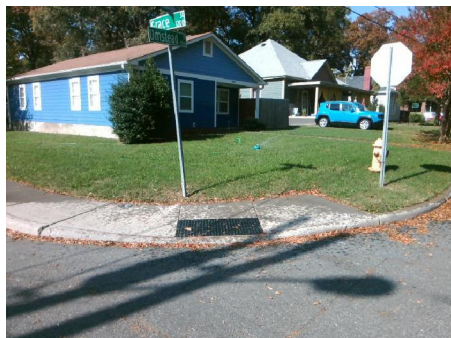
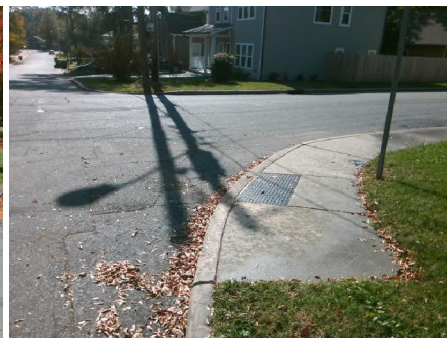
Possible Solutions:		Remove & Replace Entire Ramp.					
	Surveyor Notes:		N/A					
	PROW/ADA:		R304.2.2, R304.5.3					
	Street 1 Name		UMSTEAD ST					
	Stop Condition-Street 2		StopSign					
	Street 2 Name		N/A					
	Stop Condition-Street 1		N/A					
	Total Cost:		\$ 1850.00					
			Compliance	Description	Data	Compliance	Description	Data
			N/A	Ramp Length (in)	62.0	No	Ramp Slope (%)	9.5
			Yes	Ramp Width (in)	48.5	No	Ramp XSlope (%)	2.1
			N/A	Flare Type LT	N/A	N/A	Flare Type RT	N/A
			N/A	Flare Slope LT (%)	N/A	N/A	Flare Slope RT (%)	N/A
			N/A	Flare Traversable LT?	N/A	N/A	Flare Traversable RT?	N/A
			N/A	Landing Length (in)	N/A	N/A	DWS Provided?	N/A
			N/A	Landing Width (in)	N/A	N/A	DWS Contrast?	N/A
			N/A	Landing Slope (%)	N/A	N/A	DWS Length (in)	N/A
			N/A	Landing X Slope (%)	N/A	N/A	DWS Full Width?	N/A
			N/A	Landing Curb? (Y/N)	N/A	N/A	DWS Offset (in)	N/A

N/A	Shared Landing?	N/A			
			N/A	Gutter Ponding?	N/A	N/A	Gutter Slope (%)	N/A
			N/A	Gutter Lip Ht (in)	N/A	N/A	Gutter X Slope (%)	N/A
			N/A	Painted X Walk1?	No	N/A	Painted X Walk2?	N/A
				X Walk 1 Direction	To E		X Walk 2 Direction	N/A
			N/A	X Walk 1 Width (in)	N/A	N/A	X Walk 2 Width (in)	N/A
				X Walk 1 Slope (%)	4.3		X Walk 2 Slope (%)	N/A
				X Walk 1 X Slope (%)	1.3		X Walk 2 X Slope (%)	N/A
			N/A	Ramp inside XWalk1?	N/A	N/A	Ramp inside XWalk2?	N/A
				Road Slope (%)	N/A	N/A	Clear Space?	N/A
				Road X Slope (%)	N/A	N/A	Clear Space to XWalk (in)	N/A
			N/A	Any Obstructions?	N/A	N/A	Storm Grate/Utility Hazard?	N/A
				Obstruction Type			Storm Grate/Utility Type	
					N/A			N/A
						Yes	Surface Condition? (G/P)	Good
