Access Compliance Report

Public Rights-of-Way

(Curb Ramps)

Intersection ID: N/A	Main Street: E MARTIN LUTHER KING JR BV	Cross Street: S CALDWELL ST	Location: SW
ADA ID: 501574A069D1	Ramp Type: Perp	Initial Pass/Fail: Fail	Overall Compliance: No
Severity Score: 13.75			
Codes/Mitigation Info/Possible Solution		Field Measurements/Component Compliance

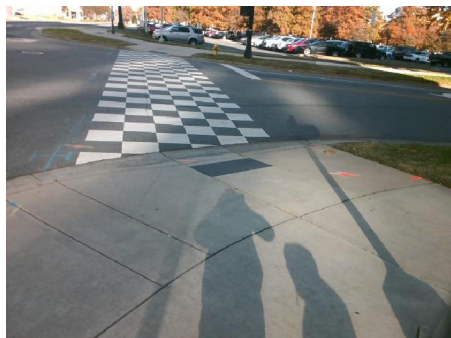
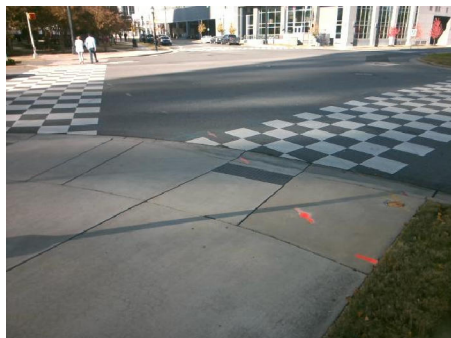
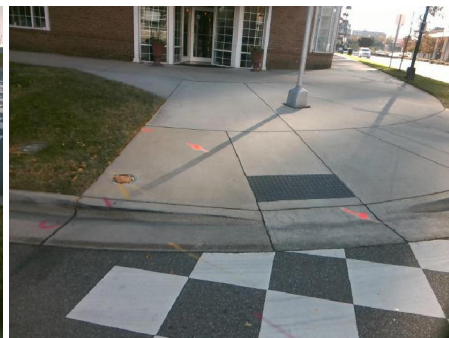
Compliance	Description	Data	Compliance	Description	Data
N/A	Ramp Length (in)	95.0	No	Ramp Slope (%)	10.0
Yes	Ramp Width (in)	48.0	Yes	Ramp XSlope (%)	4.6
N/A	Flare Type LT	N/A	N/A	Flare Type RT	N/A
N/A	Flare Slope LT (%)	N/A	N/A	Flare Slope RT (%)	N/A
N/A	Flare Traversable LT?	No	N/A	Flare Traversable RT?	No
N/A	Landing Length (in)	N/A	N/A	DWS Provided?	N/A
N/A	Landing Width (in)	N/A	N/A	DWS Contrast?	N/A
N/A	Landing Slope (%)	N/A	N/A	DWS Length (in)	N/A
N/A	Landing X Slope (%)	N/A	N/A	DWS Full Width?	N/A
N/A	Landing Curb? (Y/N)	N/A	N/A	DWS Offset (in)	N/A
N/A	Shared Landing?	N/A			
N/A	Gutter Ponding?	N/A	N/A	Gutter Slope (%)	N/A
N/A	Gutter Lip Ht (in)	N/A	N/A	Gutter X Slope (%)	N/A
N/A	Painted X Walk1?	Yes	N/A	Painted X Walk2?	N/A
	X Walk 1 Direction	To NE		X Walk 2 Direction	N/A
N/A	X Walk 1 Width (in)	144.0	N/A	X Walk 2 Width (in)	N/A
	X Walk 1 Slope (%)	2.1		X Walk 2 Slope (%)	N/A
	X Walk 1 X Slope (%)	5.8		X Walk 2 X Slope (%)	N/A

N/A	Ramp inside XWalk1?	Yes	N/A	Ramp inside XWalk2?	N/A
	Road Slope (%)	N/A	N/A	Clear Space?	N/A
	Road X Slope (%)	N/A	N/A	Clear Space to XWalk (in)	N/A
N/A	Any Obstructions?	N/A	N/A	Storm Grate/Utility Hazard?	N/A
	Obstruction Type			Storm Grate/Utility Type	
		N/A			N/A
		Yes		Surface Condition? (G/P)	Good

Remove & Replace Entire Ramp.
