# Access Compliance Report

## Public Rights-of-Way

### (Curb Ramps)

Intersection ID: 13769	Main Street: E_3RD_ST	Cross Street: CHERRY_ST	Location: SE
ADA ID: 5015DA0D09B8	Ramp Type: Perp	Initial Pass/Fail: Fail	Overall Compliance: No
Codes/Mitigation Info/Possible Solution		Field Measurements/Component Compliance	
Severity Score: 46.25

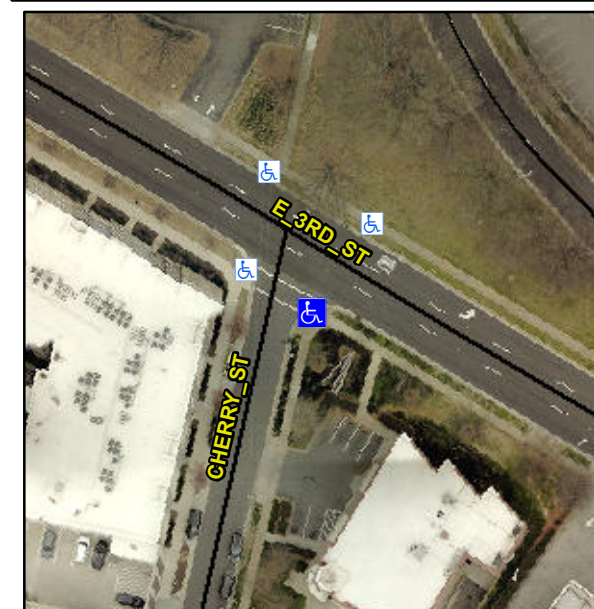
**Not Found, R304.5.1, R304.2.2, R304.5.3**

Compliance	Description	Data	Compliance	Description	Data
N/A	Ramp Length (in)	60.0	No	Ramp Slope (%)	10.3
No	Ramp Width (in)	39.5	No	Ramp XSlope (%)	7.0
N/A	Flare Type LT	N/A	N/A	Flare Type RT	N/A
N/A	Flare Slope LT (%)	N/A	N/A	Flare Slope RT (%)	N/A
N/A	Flare Traversable LT?	N/A	N/A	Flare Traversable RT?	N/A
N/A	Landing Length (in)	N/A	N/A	DWS Provided?	N/A
N/A	Landing Width (in)	N/A	N/A	DWS Contrast?	N/A
N/A	Landing Slope (%)	N/A	N/A	DWS Length (in)	N/A
N/A	Landing X Slope (%)	N/A	N/A	DWS Full Width?	N/A
N/A	Landing Curb? (Y/N)	N/A	N/A	DWS Offset (in)	N/A
N/A	Shared Landing?	N/A			
N/A	Gutter Ponding?	N/A	N/A	Gutter Slope (%)	N/A
N/A	Gutter Lip Ht (in)	N/A	N/A	Gutter X Slope (%)	N/A
N/A	Painted X Walk1?	Yes	N/A	Painted X Walk2?	N/A
	X Walk 1 Direction	To NW		X Walk 2 Direction	N/A
N/A	X Walk 1 Width (in)	104.5	N/A	X Walk 2 Width (in)	N/A
	X Walk 1 Slope (%)	3.7		X Walk 2 Slope (%)	N/A
	X Walk 1 X Slope (%)	3.3		X Walk 2 X Slope (%)	N/A

N/A	Ramp inside XWalk1?	Yes	N/A	Ramp inside XWalk2?	N/A
	Road Slope (%)	N/A	N/A	Clear Space?	N/A
	Road X Slope (%)	N/A	N/A	Clear Space to XWalk (in)	N/A
N/A	Any Obstructions?	N/A	N/A	Storm Grate/Utility Hazard?	N/A
	Obstruction Type			Storm Grate/Utility Type	
		N/A			N/A
			Yes	Surface Condition? (G/P)	Good

**Remove & Replace Entire Ramp.**

Total Cost: \$ 1850.00
