Access Compliance Report

Public Rights-of-Way

(Curb Ramps)

Intersection ID: N/A	Main Street: STEEL_CREEK_RD	Cross Street: SHOPTON_RD	Location: E
ADA ID: 50185BB35C37	Ramp Type: Perp	Initial Pass/Fail: Fail	Overall Compliance: No
Severity Score: 21.25			
Codes/Mitigation Info/Possible Solution		Field Measurements/Component Compliance

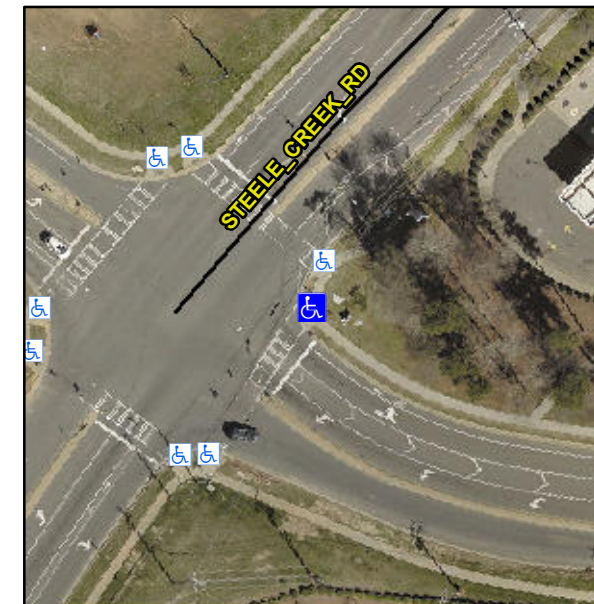
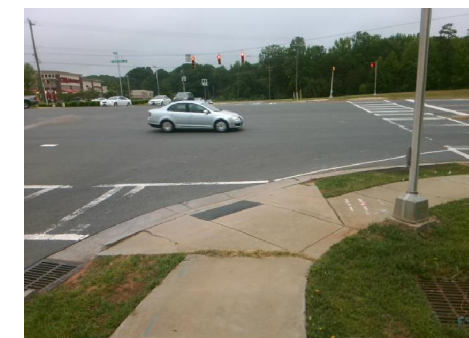
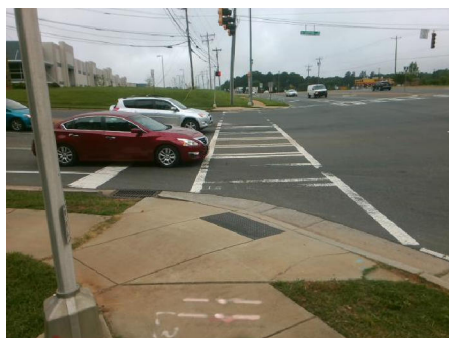
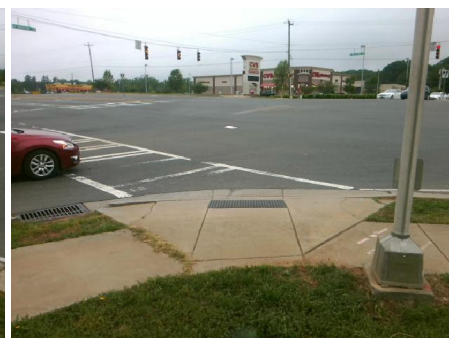
Not Found, R304.5.1, R304.2.2

Compliance	Description	Data	Compliance	Description	Data
N/A	Ramp Length (in)	52.0	No	Ramp Slope (%)	8.9
No	Ramp Width (in)	45.0	Yes	Ramp XSlope (%)	1.6
N/A	Flare Type LT	N/A	N/A	Flare Type RT	N/A
N/A	Flare Slope LT (%)	N/A	N/A	Flare Slope RT (%)	N/A
N/A	Flare Traversable LT?	N/A	N/A	Flare Traversable RT?	N/A
N/A	Landing Length (in)	N/A	N/A	DWS Provided?	N/A
N/A	Landing Width (in)	N/A	N/A	DWS Contrast?	N/A
N/A	Landing Slope (%)	N/A	N/A	DWS Length (in)	N/A
N/A	Landing X Slope (%)	N/A	N/A	DWS Full Width?	N/A
N/A	Landing Curb? (Y/N)	N/A	N/A	DWS Offset (in)	N/A
N/A	Shared Landing?	N/A			
N/A	Gutter Ponding?	N/A	N/A	Gutter Slope (%)	N/A
N/A	Gutter Lip Ht (in)	N/A	N/A	Gutter X Slope (%)	N/A
N/A	Painted X Walk1?	Yes	N/A	Painted X Walk2?	N/A
	X Walk 1 Direction	To SW		X Walk 2 Direction	N/A
N/A	X Walk 1 Width (in)	110.0	N/A	X Walk 2 Width (in)	N/A
	X Walk 1 Slope (%)	0.9		X Walk 2 Slope (%)	N/A
	X Walk 1 X Slope (%)	2.9		X Walk 2 X Slope (%)	N/A

N/A	Ramp inside XWalk1?	Yes	N/A	Ramp inside XWalk2?	N/A
	Road Slope (%)	N/A	N/A	Clear Space?	N/A
	Road X Slope (%)	N/A	N/A	Clear Space to XWalk (in)	N/A
N/A	Any Obstructions?	N/A	N/A	Storm Grate/Utility Hazard?	N/A
	Obstruction Type			Storm Grate/Utility Type	
		N/A			N/A
		Yes		Surface Condition? (G/P)	Good

Possible Solutions:

Remove & Replace Entire Ramp.
