Access Compliance Report

Public Rights-of-Way

(Curb Ramps)

Intersection ID: 49932	Main Street: WOBURN_RD	Cross Street: PAXTON_RUN_RD	Location: SE
ADA ID: 501A3B50F539	Ramp Type: Perp	Initial Pass/Fail: Pass	Overall Compliance: No
Severity Score: 0			
Codes/Mitigation Info/Possible Solution		Field Measurements/Component Compliance

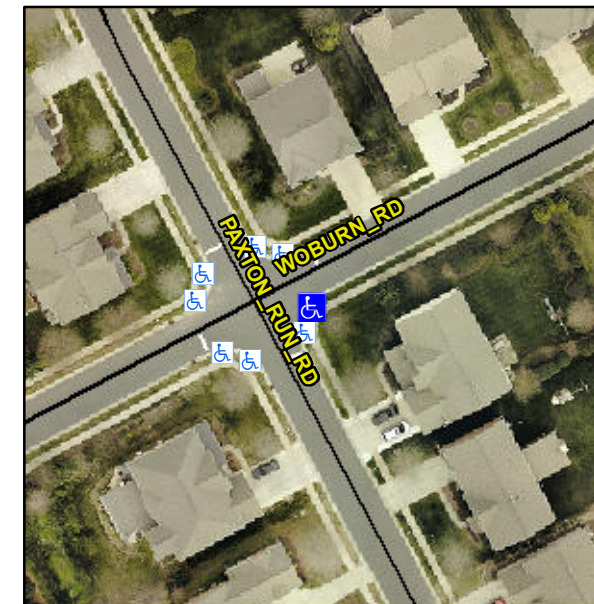
Not Found, R305.2

Compliance	Description	Data	Compliance	Description	Data
N/A	Ramp Length (in)	47.0	Yes	Ramp Slope (%)	5.9
Yes	Ramp Width (in)	48.0	Yes	Ramp XSlope (%)	1.5
N/A	Flare Type LT	Sloped	N/A	Flare Type RT	N/A
N/A	Flare Slope LT (%)	9.2	Yes	Flare Slope RT (%)	5.8
N/A	Flare Traversable LT?	Yes	N/A	Flare Traversable RT?	Yes
Yes	Landing Length (in)	48.0	Yes	DWS Provided?	Yes
Yes	Landing Width (in)	48.0	Yes	DWS Contrast?	Yes
Yes	Landing Slope (%)	1.7	Yes	DWS Length (in)	24.5
Yes	Landing X Slope (%)	1.1	Yes	DWS Full Width?	Yes
N/A	Landing Curb? (Y/N)	No	No	DWS Offset (in)	5.5
N/A	Shared Landing?	No			
Yes	Gutter Ponding?	No	Yes	Gutter Slope (%)	3.7
Yes	Gutter Lip Ht (in)	0.0	Yes	Gutter X Slope (%)	1.7
N/A	Painted X Walk1?	No	N/A	Painted X Walk2?	N/A
	X Walk 1 Direction	To NW		X Walk 2 Direction	N/A
N/A	X Walk 1 Width (in)	N/A	N/A	X Walk 2 Width (in)	N/A
	X Walk 1 Slope (%)	3.5		X Walk 2 Slope (%)	N/A
	X Walk 1 X Slope (%)	2.1		X Walk 2 X Slope (%)	N/A

N/A	Ramp inside XWalk1?	N/A	N/A	Ramp inside XWalk2?	N/A
	Road Slope (%)	N/A	N/A	Clear Space?	Yes
	Road X Slope (%)	N/A	N/A	Clear Space to XWalk (in)	N/A
Yes	Any Obstructions?	No	Yes	Storm Grate/Utility Hazard?	No
	Obstruction Type			Storm Grate/Utility Type	
		N/A			N/A
			Yes	Surface Condition? (G/P)	Good

Possible Solutions:

Remove & Replace Entire Ramp.
