# Access Compliance Report

## Public Rights-of-Way

### (Curb Ramps)

Intersection ID: 28279	Main Street: COMMUNITY_HOUSE_RD	Cross Street: PURCHASE_ST	Location: E
ADA ID: 5026F91F1056	Ramp Type: Directional1	Initial Pass/Fail: Fail	Overall Compliance: No
Severity Score: 12.5			
Codes/Mitigation Info/Possible Solution		Field Measurements/Component Compliance

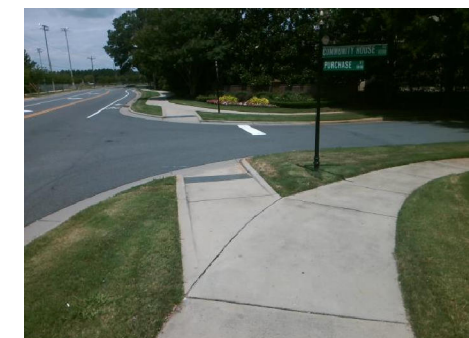
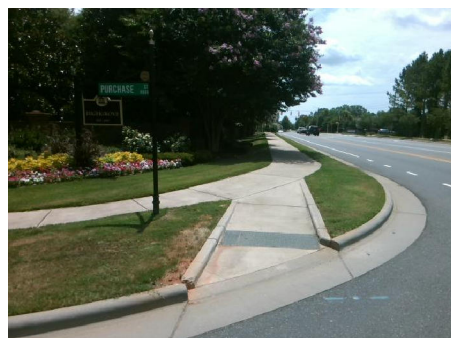
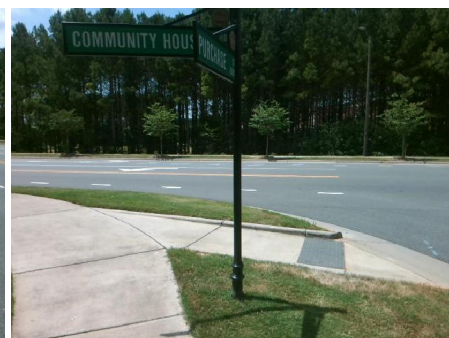
Compliance	Description	Data	Compliance	Description	Data
N/A	Ramp Length (in)	135.0	N/A	Grade Break?	N/A
Yes	Ramp Width (in)	57.0	N/A	Grade Break Slope (%)	0.0
No	Ramp Slope (%)	8.6	N/A	Grade Break XSlope (%)	0.0
Yes	Ramp XSlope (%)	0.2			
N/A	Flare Type LT	N/A	N/A	Flare Type RT	N/A
N/A	Flare Slope LT (%)	N/A	N/A	Flare Slope RT (%)	0.0
N/A	Flare Traversable LT?	N/A	N/A	Flare Traversable RT?	N/A
N/A	Landing Length (in)	0.0	N/A	DWS Provided?	N/A
N/A	Landing Width (in)	0.0	N/A	DWS Contrast?	N/A
N/A	Landing Slope (%)	0.0	N/A	DWS Length (in)	N/A
N/A	Landing X Slope (%)	0.0	N/A	DWS Full Width?	N/A
N/A	Landing Curb? (Y/N)	N/A	N/A	DWS Offset LT (in)	N/A
N/A	Shared Landing?	N/A	N/A	DWS Offset RT (in)	N/A
N/A	Gutter Ponding?	0.0	N/A	Gutter Slope (%)	N/A
N/A	Gutter Lip Ht (in)	0.0	N/A	Gutter X Slope (%)	N/A
N/A	Painted X Walk1?	No		Road Slope (%)	1.6
	X Walk 1 Direction	To NW		Road X Slope (%)	4.6
	X Walk 1 Width (in)	N/A		Clear Space?	N/A

X Walk 1 Slope (%)	1.6	N/A	Clear Space to XWalk (in)	N/A
	X Walk 1 X Slope (%)	4.6	N/A	Storm Grate/Utility Hazard?	N/A
N/A	Ramp inside XWalk1?	N/A		Storm Grate/Utility Type	
N/A	Any Obstructions?	N/A			N/A
	Obstruction Type		Yes	Surface Condition? (G/P)	Good
			N/A	Curb Slope (%)	8.2

**Remove & Replace Entire Ramp.**
