# Access Compliance Report

## Public Rights-of-Way

### (Curb Ramps)

| Intersection ID: 29389 | Main Street: GOLD_PAN_RD | Cross Street: REEDY_PLANTATION_RD | Location: SW |

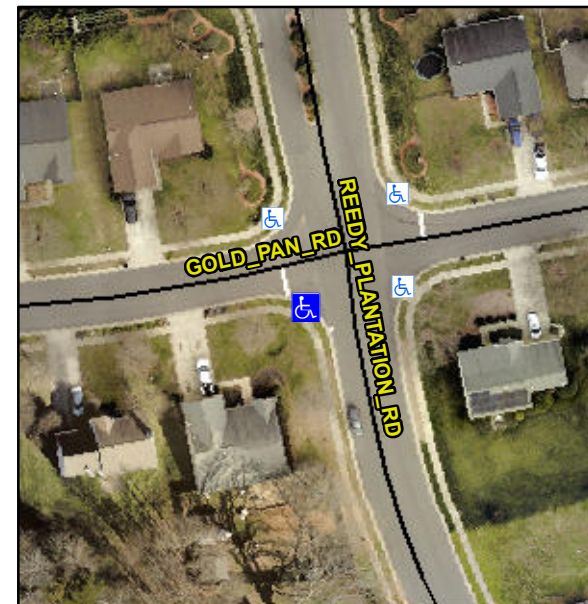
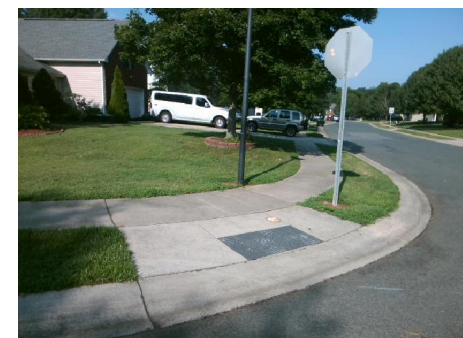
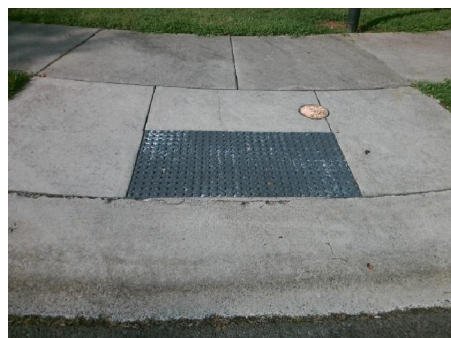
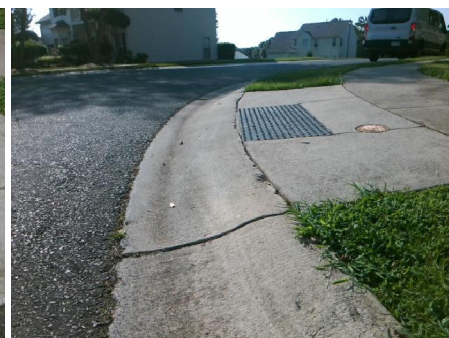
| ADA ID: 502CE9AC3C4C | Ramp Type: PerpDiag | Initial Pass/Fail: Fail | Overall Compliance: No |

| Severity Score: 21.25 | | | |

**Not Found, R304.5.1, R304.5.3**

| Compliance | Description | Data | Compliance | Description | Data |
|---|---|---|---|---|---|
| N/A | Ramp Length (in) | 46.5 | Yes | Ramp Slope (%) | 5.6 |
| No | Ramp Width (in) | 47.5 | No | Ramp XSlope (%) | 5.2 |

**Remove & Replace Curb Ramp With Two New Directional Ramps or Equivalent.**

Total Cost: \$ 3200.00
