Access Compliance Report

Public Rights-of-Way

(Curb Ramps)

Intersection ID: 14349	Main Street: REMOUNT_RD	Cross Street: TOOMEY_AV	Location: S
ADA ID: 502DCE1C5A3F	Ramp Type: Perp	Initial Pass/Fail: Fail	Overall Compliance: No
Severity Score: 50			
Codes/Mitigation Info/Possible Solution		Field Measurements/Component Compliance

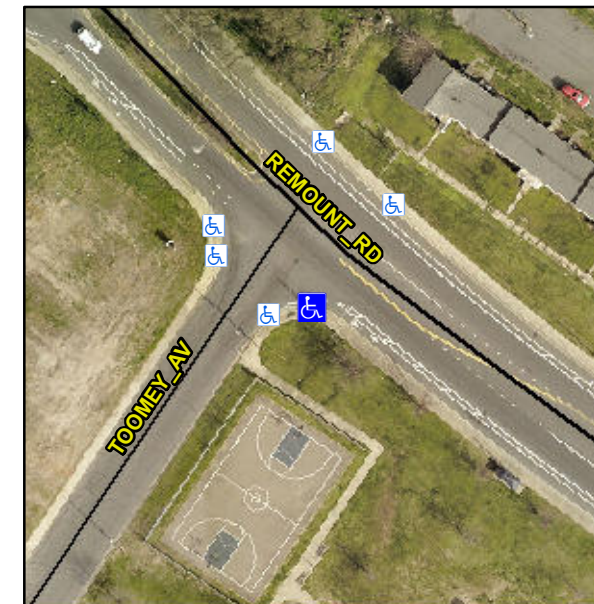
Not Found, R304.2.2, R304.5.3

Compliance	Description	Data	Compliance	Description	Data
N/A	Ramp Length (in)	60.0	No	Ramp Slope (%)	12.0
Yes	Ramp Width (in)	48.0	No	Ramp XSlope (%)	7.3
N/A	Flare Type LT	N/A	N/A	Flare Type RT	N/A
N/A	Flare Slope LT (%)	N/A	N/A	Flare Slope RT (%)	N/A
N/A	Flare Traversable LT?	N/A	N/A	Flare Traversable RT?	N/A
N/A	Landing Length (in)	N/A	N/A	DWS Provided?	N/A
N/A	Landing Width (in)	N/A	N/A	DWS Contrast?	N/A
N/A	Landing Slope (%)	N/A	N/A	DWS Length (in)	N/A
N/A	Landing X Slope (%)	N/A	N/A	DWS Full Width?	N/A
N/A	Landing Curb? (Y/N)	N/A	N/A	DWS Offset (in)	N/A
N/A	Shared Landing?	N/A			
N/A	Gutter Ponding?	N/A	N/A	Gutter Slope (%)	N/A
N/A	Gutter Lip Ht (in)	N/A	N/A	Gutter X Slope (%)	N/A
N/A	Painted X Walk1?	No	N/A	Painted X Walk2?	N/A
	X Walk 1 Direction	To NE		X Walk 2 Direction	N/A
N/A	X Walk 1 Width (in)	N/A	N/A	X Walk 2 Width (in)	N/A
	X Walk 1 Slope (%)	1.4		X Walk 2 Slope (%)	N/A
	X Walk 1 X Slope (%)	2.8		X Walk 2 X Slope (%)	N/A

Possible Solutions:

Remove & Replace Entire Ramp.

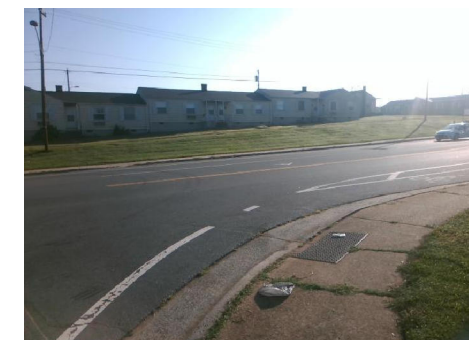
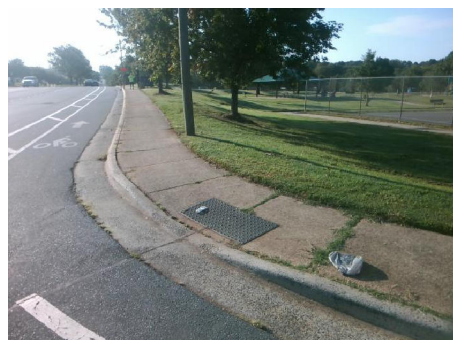
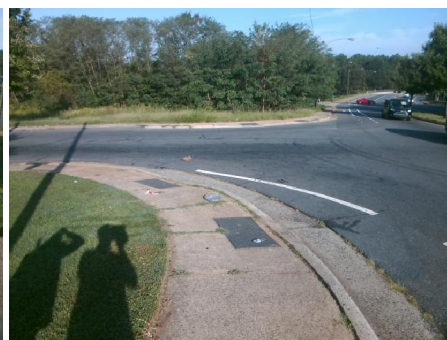
N/A	Ramp inside XWalk1?	N/A	N/A	Ramp inside XWalk2?	N/A
	Road Slope (%)	N/A	N/A	Clear Space?	N/A
	Road X Slope (%)	N/A	N/A	Clear Space to XWalk (in)	N/A
N/A	Any Obstructions?	N/A	N/A	Storm Grate/Utility Hazard?	N/A
	Obstruction Type			Storm Grate/Utility Type	
		N/A			N/A
			Yes	Surface Condition? (G/P)	Good
