Access Compliance Report

Public Rights-of-Way

(Curb Ramps)

Intersection ID: 9490	Main Street: BARRINGTON_DR	Cross Street: CRAFTSBURY_DR	Location: S
ADA ID: 5033F2AAC632	Ramp Type: Perp	Initial Pass/Fail: Pass	Overall Compliance: No
		Severity Score: 14

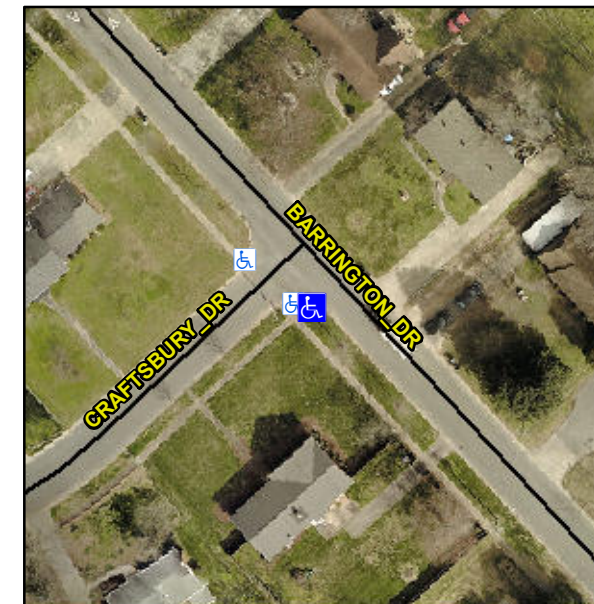
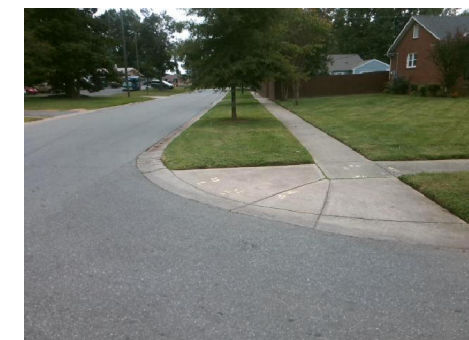
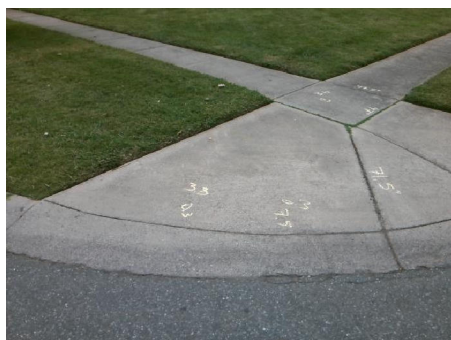
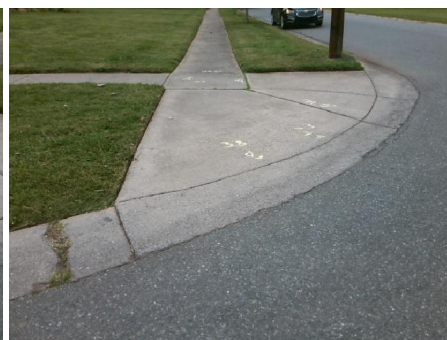
Not Found, R304.2.1, R304.5.3, R305, R302.7

Compliance	Description	Data	Compliance	Description	Data
N/A	Ramp Length (in)	71.5	Yes	Ramp Slope (%)	7.5
Yes	Ramp Width (in)	81.0	Yes	Ramp XSlope (%)	0.3
N/A	Flare Type LT	Sloped	N/A	Flare Type RT	N/A
N/A	Flare Slope LT (%)	8.1	Yes	Flare Slope RT (%)	0.8
N/A	Flare Traversable LT?	No	N/A	Flare Traversable RT?	Yes
No	Landing Length (in)	47.0	No	DWS Provided?	No
No	Landing Width (in)	47.5	N/A	DWS Contrast?	No
Yes	Landing Slope (%)	0.3	N/A	DWS Length (in)	N/A
No	Landing X Slope (%)	3.6	N/A	DWS Full Width?	No
N/A	Landing Curb? (Y/N)	No	N/A	DWS Offset (in)	N/A
N/A	Shared Landing?	Yes			
No	Gutter Ponding?	Yes	Yes	Gutter Slope (%)	1.5
Yes	Gutter Lip Ht (in)	0.0	Yes	Gutter X Slope (%)	0.4
N/A	Painted X Walk1?	No	N/A	Painted X Walk2?	N/A
	X Walk 1 Direction	To E		X Walk 2 Direction	N/A
N/A	X Walk 1 Width (in)	N/A	N/A	X Walk 2 Width (in)	N/A
	X Walk 1 Slope (%)	3.8		X Walk 2 Slope (%)	N/A
	X Walk 1 X Slope (%)	0.3		X Walk 2 X Slope (%)	N/A

N/A	Ramp inside XWalk1?	N/A	N/A	Ramp inside XWalk2?	N/A
	Road Slope (%)	N/A	N/A	Clear Space?	Yes
	Road X Slope (%)	N/A	N/A	Clear Space to XWalk (in)	N/A
Yes	Any Obstructions?	No	Yes	Storm Grate/Utility Hazard?	No
	Obstruction Type			Storm Grate/Utility Type	
		N/A			N/A
			Yes	Surface Condition? (G/P)	Good

Possible Solutions:

Remove & Replace Entire Ramp.
