Access Compliance Report

Public Rights-of-Way

(Curb Ramps)

Intersection ID: 4964	Main Street: BREEZY_MORN_LN	Cross Street: HEDGECREST_PL	Location: E
ADA ID: 5044D2AAC2C0	Ramp Type: Perp	Initial Pass/Fail: Fail	Overall Compliance: No
			Severity Score: 26.25

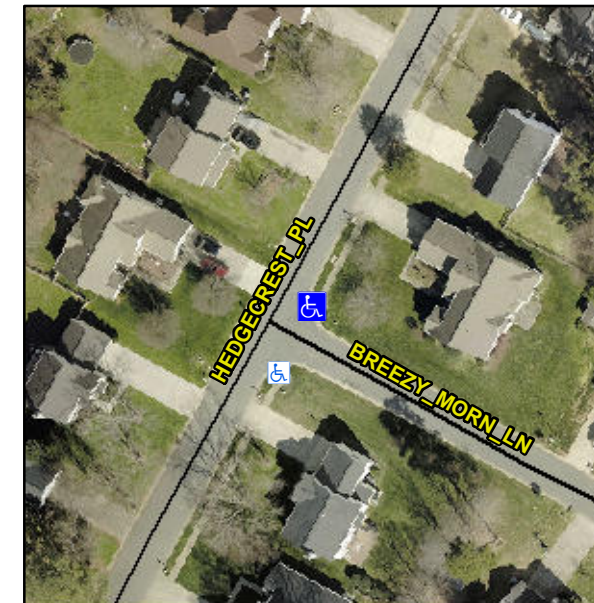
Not Found, R304.2.2, R304.5.3

Compliance	Description	Data	Compliance	Description	Data
N/A	Ramp Length (in)	48.0	No	Ramp Slope (%)	14.8
Yes	Ramp Width (in)	48.0	No	Ramp XSlope (%)	2.8
N/A	Flare Type LT	N/A	N/A	Flare Type RT	N/A
N/A	Flare Slope LT (%)	N/A	N/A	Flare Slope RT (%)	N/A
N/A	Flare Traversable LT?	N/A	N/A	Flare Traversable RT?	N/A
N/A	Landing Length (in)	N/A	N/A	DWS Provided?	N/A
N/A	Landing Width (in)	N/A	N/A	DWS Contrast?	N/A
N/A	Landing Slope (%)	N/A	N/A	DWS Length (in)	N/A
N/A	Landing X Slope (%)	N/A	N/A	DWS Full Width?	N/A
N/A	Landing Curb? (Y/N)	N/A	N/A	DWS Offset (in)	N/A
N/A	Shared Landing?	N/A			
N/A	Gutter Ponding?	N/A	N/A	Gutter Slope (%)	N/A
N/A	Gutter Lip Ht (in)	N/A	N/A	Gutter X Slope (%)	N/A
N/A	Painted X Walk1?	No	N/A	Painted X Walk2?	N/A
	X Walk 1 Direction	To SW		X Walk 2 Direction	N/A
N/A	X Walk 1 Width (in)	N/A	N/A	X Walk 2 Width (in)	N/A
	X Walk 1 Slope (%)	1.4		X Walk 2 Slope (%)	N/A
	X Walk 1 X Slope (%)	2.8		X Walk 2 X Slope (%)	N/A

N/A	Ramp inside XWalk1?	N/A	N/A	Ramp inside XWalk2?	N/A
	Road Slope (%)	N/A	N/A	Clear Space?	N/A
	Road X Slope (%)	N/A	N/A	Clear Space to XWalk (in)	N/A
N/A	Any Obstructions?	N/A	N/A	Storm Grate/Utility Hazard?	N/A
	Obstruction Type			Storm Grate/Utility Type	
		N/A			N/A
			Yes	Surface Condition? (G/P)	Good

Remove & Replace Entire Ramp.
