# Access Compliance Report

## Public Rights-of-Way

Intersection ID: 5075	Main Street: FERNMOSS_CT	Cross Street: HEDGECREST_PL	Location: SW
ADA ID: 504A928F3CBE	Ramp Type: Directional1	Initial Pass/Fail: Fail	Overall Compliance: No
			Severity Score: 21.25

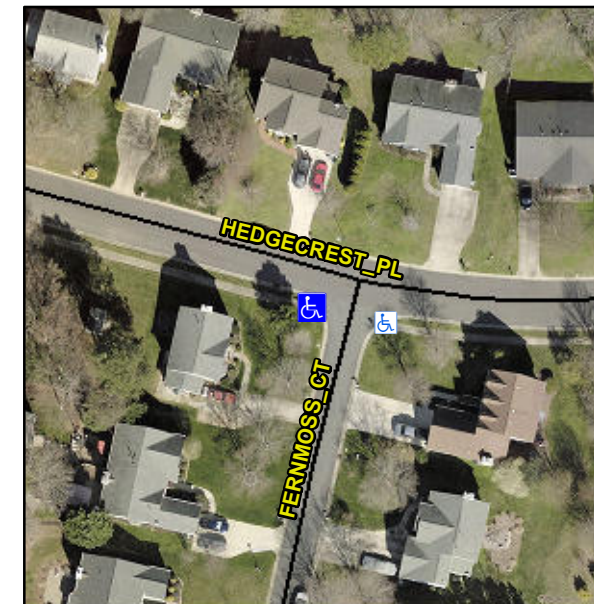
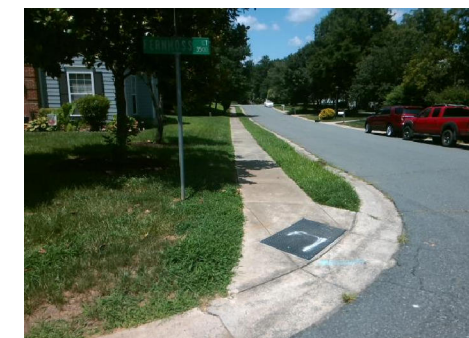
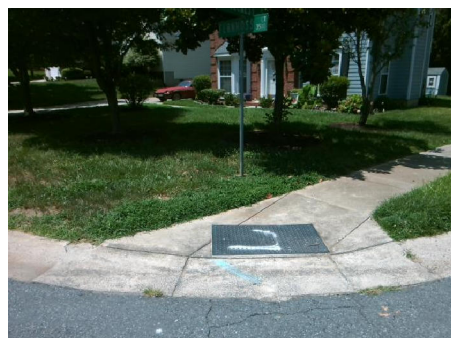
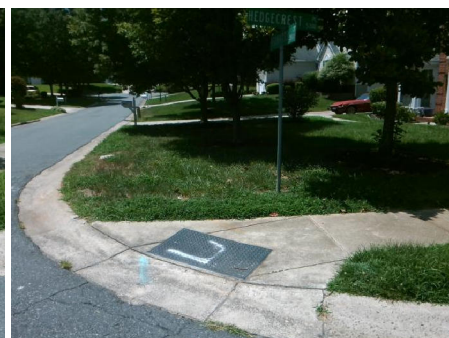
**R304.5.1, R304.2.2**

Compliance	Description	Data	Compliance	Description	Data
N/A	Ramp Length (in)	43.0	N/A	Grade Break?	N/A
No	Ramp Width (in)	42.5	N/A	Grade Break Slope (%)	0.0
No	Ramp Slope (%)	9.0	N/A	Grade Break XSlope (%)	0.0
Yes	Ramp XSlope (%)	1.0			
N/A	Flare Type LT	N/A	N/A	Flare Type RT	N/A
N/A	Flare Slope LT (%)	N/A	N/A	Flare Slope RT (%)	0.0
N/A	Flare Traversable LT?	N/A	N/A	Flare Traversable RT?	N/A
N/A	Landing Length (in)	0.0	N/A	DWS Provided?	N/A
N/A	Landing Width (in)	0.0	N/A	DWS Contrast?	N/A
N/A	Landing Slope (%)	0.0	N/A	DWS Length (in)	N/A
N/A	Landing X Slope (%)	0.0	N/A	DWS Full Width?	N/A
N/A	Landing Curb? (Y/N)	N/A	N/A	DWS Offset LT (in)	N/A
N/A	Shared Landing?	N/A	N/A	DWS Offset RT (in)	N/A
N/A	Gutter Ponding?	0.0	N/A	Gutter Slope (%)	N/A
N/A	Gutter Lip Ht (in)	0.0	N/A	Gutter X Slope (%)	N/A
N/A	Painted X Walk1?	No		Road Slope (%)	5.1
	X Walk 1 Direction	To E		Road X Slope (%)	4.4
	X Walk 1 Width (in)	N/A		Clear Space?	N/A

X Walk 1 Slope (%)	5.1	N/A	Clear Space to XWalk (in)	N/A
	X Walk 1 X Slope (%)	4.4	N/A	Storm Grate/Utility Hazard?	N/A
N/A	Ramp inside XWalk1?	N/A		Storm Grate/Utility Type	
N/A	Any Obstructions?	N/A			N/A
	Obstruction Type		Yes	Surface Condition? (G/P)	Good
			N/A	Curb Slope (%)	N/A

**Remove & Replace Entire Ramp.**

Total Cost: \$ 1600.00
