Access Compliance Report

Public Rights-of-Way

(Curb Ramps)

Intersection ID: 10036927	Main Street: S_SHARON_AMITY_RD	Cross Street: N/A	Location: NE
ADA ID: 5057A598863E	Ramp Type: Directional1	Initial Pass/Fail: Fail	Overall Compliance: No
Severity Score: 1.25			
Codes/Mitigation Info/Possible Solution		Field Measurements/Component Compliance

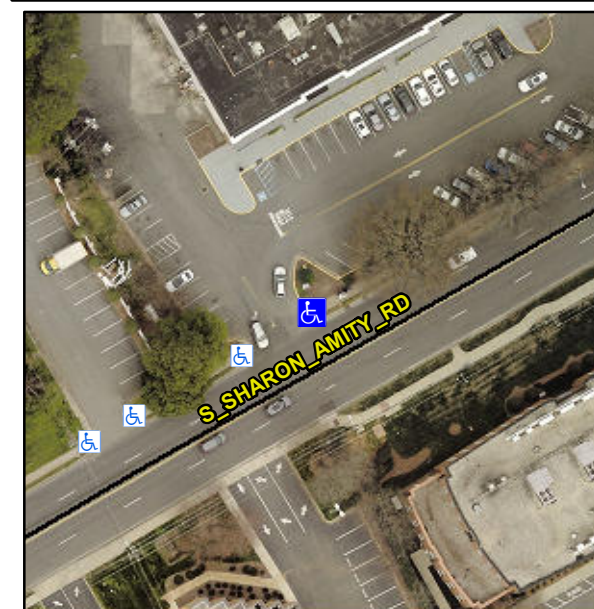
Compliance	Description	Data	Compliance	Description	Data
N/A	Ramp Length (in)	75.0	N/A	Grade Break?	N/A
Yes	Ramp Width (in)	62.0	N/A	Grade Break Slope (%)	0.0
Yes	Ramp Slope (%)	7.7	N/A	Grade Break XSlope (%)	0.0
No	Ramp XSlope (%)	2.2			
N/A	Flare Type LT	N/A	N/A	Flare Type RT	N/A
N/A	Flare Slope LT (%)	N/A	N/A	Flare Slope RT (%)	0.0
N/A	Flare Traversable LT?	N/A	N/A	Flare Traversable RT?	N/A
N/A	Landing Length (in)	0.0	N/A	DWS Provided?	N/A
N/A	Landing Width (in)	0.0	N/A	DWS Contrast?	N/A
N/A	Landing Slope (%)	0.0	N/A	DWS Length (in)	N/A
N/A	Landing X Slope (%)	0.0	N/A	DWS Full Width?	N/A
N/A	Landing Curb? (Y/N)	N/A	N/A	DWS Offset LT (in)	N/A
N/A	Shared Landing?	N/A	N/A	DWS Offset RT (in)	N/A
N/A	Gutter Ponding?	0.0	N/A	Gutter Slope (%)	N/A
N/A	Gutter Lip Ht (in)	0.0	N/A	Gutter X Slope (%)	N/A
N/A	Painted X Walk1?	No		Road Slope (%)	4.0
	X Walk 1 Direction	To SW		Road X Slope (%)	0.5
	X Walk 1 Width (in)	N/A		Clear Space?	N/A

X Walk 1 Slope (%)	4.0	N/A	Clear Space to XWalk (in)	N/A
	X Walk 1 X Slope (%)	0.5	N/A	Storm Grate/Utility Hazard?	N/A
N/A	Ramp inside XWalk1?	N/A		Storm Grate/Utility Type	
N/A	Any Obstructions?	N/A			N/A
	Obstruction Type		Yes	Surface Condition? (G/P)	Good
			N/A	Curb Slope (%)	5.0

Possible Solutions:

Remove & Replace Entire Ramp.
