Access Compliance Report

Public Rights-of-Way

(Curb Ramps)

Intersection ID: 4842	Main Street: FARLOW_RD	Cross Street: LOWEN_RD	Location: SW
ADA ID: 506710EB62D9	Ramp Type: Perp	Initial Pass/Fail: Fail	Overall Compliance: No
Severity Score: 21.25			
Codes/Mitigation Info/Possible Solution		Field Measurements/Component Compliance

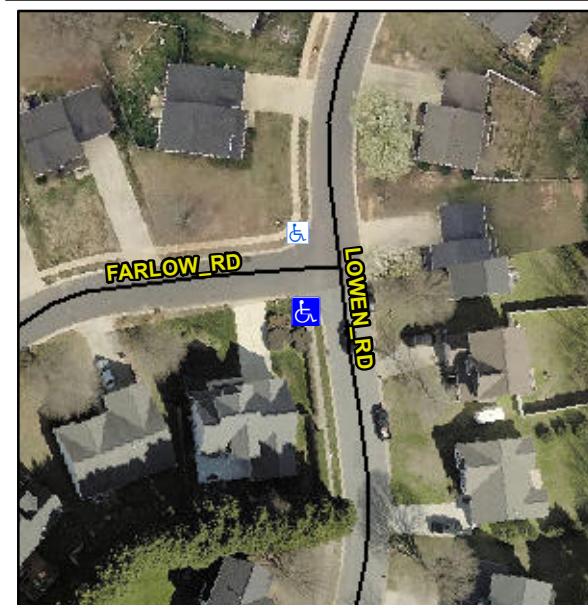
Not Found, R304.5.1, R304.2.2

Compliance	Description	Data	Compliance	Description	Data
N/A	Ramp Length (in)	48.0	No	Ramp Slope (%)	10.7
No	Ramp Width (in)	43.0	Yes	Ramp XSlope (%)	1.2
N/A	Flare Type LT	N/A	N/A	Flare Type RT	N/A
N/A	Flare Slope LT (%)	N/A	N/A	Flare Slope RT (%)	N/A
N/A	Flare Traversable LT?	N/A	N/A	Flare Traversable RT?	N/A
N/A	Landing Length (in)	N/A	N/A	DWS Provided?	N/A
N/A	Landing Width (in)	N/A	N/A	DWS Contrast?	N/A
N/A	Landing Slope (%)	N/A	N/A	DWS Length (in)	N/A
N/A	Landing X Slope (%)	N/A	N/A	DWS Full Width?	N/A
N/A	Landing Curb? (Y/N)	N/A	N/A	DWS Offset (in)	N/A
N/A	Shared Landing?	N/A			
N/A	Gutter Ponding?	N/A	N/A	Gutter Slope (%)	N/A
N/A	Gutter Lip Ht (in)	N/A	N/A	Gutter X Slope (%)	N/A
N/A	Painted X Walk1?	No	N/A	Painted X Walk2?	N/A
	X Walk 1 Direction	To N		X Walk 2 Direction	N/A
N/A	X Walk 1 Width (in)	N/A	N/A	X Walk 2 Width (in)	N/A
	X Walk 1 Slope (%)	2.3		X Walk 2 Slope (%)	N/A
	X Walk 1 X Slope (%)	4.9		X Walk 2 X Slope (%)	N/A

N/A	Ramp inside XWalk1?	N/A	N/A	Ramp inside XWalk2?	N/A
	Road Slope (%)	N/A	N/A	Clear Space?	N/A
	Road X Slope (%)	N/A	N/A	Clear Space to XWalk (in)	N/A
N/A	Any Obstructions?	N/A	N/A	Storm Grate/Utility Hazard?	N/A
	Obstruction Type			Storm Grate/Utility Type	
		N/A			N/A
			Yes	Surface Condition? (G/P)	Good

Remove & Replace Entire Ramp.
