## Access Compliance Report Public Rights-of-Way (Curb Ramps)

Intersection ID: 10040074Main Street: TUCKASEGEE\_RDCross Street: N/ALocation:NADA ID: 507399D10151Ramp Type: Directional1Initial Pass/Fail: FailOverall Compliance: NoSeverity Score: 26.25

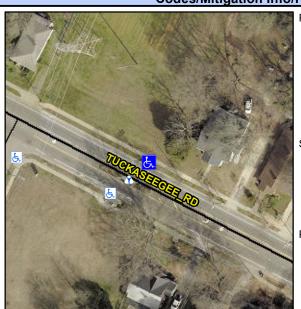
Field Measurements/Component Compliance						
Compli	ance Description	Data	Comp	liance Description	Data	
N/A	Ramp Length (in)	50.0	N/A	Grade Break?	N/A	
Yes	Ramp Width (in)	48.0	N/A	Grade Break Slope (%)	0.0	
No	Ramp Slope (%)	14.1	N/A	Grade Break XSlope (%)	0.0	
No	Ramp XSlope (%)	3.4				
N/A	Flare Type LT	N/A	N/A	Flare Type RT	N/A	
N/A	Flare Slope LT (%)	N/A	N/A	Flare Slope RT (%)	0.0	
N/A	Flare Traversable LT?	N/A	N/A	Flare Traversable RT?	N/A	
N/A	Landing Length (in)	0.0	N/A	DWS Provided?	N/A	
N/A	Landing Width (in)	0.0	N/A	DWS Contrast?	N/A	
N/A	Landing Slope (%)	0.0	N/A	DWS Length (in)	N/A	
N/A	Landing X Slope (%)	0.0	N/A	DWS Full Width?	N/A	
N/A	Landing Curb? (Y/N)	N/A	N/A	DWS Offset LT (in)	N/A	
N/A	Shared Landing?	N/A	N/A	DWS Offset RT (in)	N/A	
N/A	Gutter Ponding?	0.0	N/A	Gutter Slope (%)	N/A	
N/A	Gutter Lip Ht (in)	0.0	N/A	Gutter X Slope (%)	N/A	
N/A	Painted X Walk1?	No		Road Slope (%)	6.8	
	X Walk 1 Direction	To SW		Road X Slope (%)	1.2

X Walk 1 Width (in)	N/A		Clear Space?	N/A	
	X Walk 1 Slope (%)	6.8	N/A	Clear Space to XWalk (in)	N/A	
	X Walk 1 X Slope (%)	1.2	N/A	Storm Grate/Utility Hazard?	N/A	
N/A	Ramp inside XWalk1?	N/A		Storm Grate/Utility Type		
N/A	Any Obstructions?	N/A			N/A	
	Obstruction Type		Yes	Surface Condition? (G/P)	Good	
		N/A	N/A	Curb Slope (%)	11.1

Possible Solution	
Possible Solutions:	<u>c</u>
Remove & Replace Entire Ramp.	N
·	Υ
	N
	N
	N
	N
Surveyor Notes:	N
N/A	N
	N
	N
	N
PROW/ADA:	N
R304.2.2, R304.5.3	N
	N
	N
	N
