Access Compliance Report

Public Rights-of-Way

(Curb Ramps)

Intersection ID: 30117	Main Street: CLOONEY_LN	Cross Street: DAVIS_FOREST_LN	Location: S
ADA ID: 5086D809FA3E	Ramp Type: Perp	Initial Pass/Fail: Fail	Overall Compliance: No
Severity Score: 8.75			
Codes/Mitigation Info/Possible Solution		Field Measurements/Component Compliance

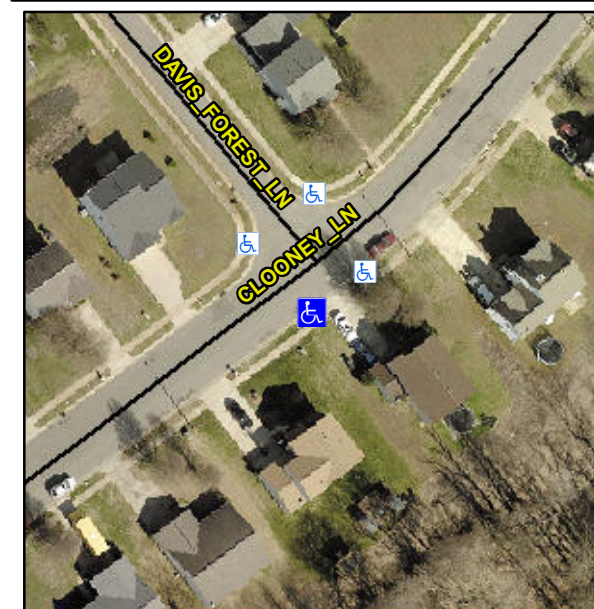
Compliance	Description	Data	Compliance	Description	Data
N/A	Ramp Length (in)	47.0	Yes	Ramp Slope (%)	7.7
No	Ramp Width (in)	40.0	Yes	Ramp XSlope (%)	1.5
N/A	Flare Type LT	N/A	N/A	Flare Type RT	N/A
N/A	Flare Slope LT (%)	N/A	N/A	Flare Slope RT (%)	N/A
N/A	Flare Traversable LT?	N/A	N/A	Flare Traversable RT?	N/A
N/A	Landing Length (in)	N/A	N/A	DWS Provided?	N/A
N/A	Landing Width (in)	N/A	N/A	DWS Contrast?	N/A
N/A	Landing Slope (%)	N/A	N/A	DWS Length (in)	N/A
N/A	Landing X Slope (%)	N/A	N/A	DWS Full Width?	N/A
N/A	Landing Curb? (Y/N)	N/A	N/A	DWS Offset (in)	N/A
N/A	Shared Landing?	N/A			
N/A	Gutter Ponding?	N/A	N/A	Gutter Slope (%)	N/A
N/A	Gutter Lip Ht (in)	N/A	N/A	Gutter X Slope (%)	N/A
N/A	Painted X Walk1?	No	N/A	Painted X Walk2?	N/A
	X Walk 1 Direction	To NW		X Walk 2 Direction	N/A
N/A	X Walk 1 Width (in)	N/A	N/A	X Walk 2 Width (in)	N/A
	X Walk 1 Slope (%)	1.1		X Walk 2 Slope (%)	N/A
	X Walk 1 X Slope (%)	2.0		X Walk 2 X Slope (%)	N/A

N/A	Ramp inside XWalk1?	N/A	N/A	Ramp inside XWalk2?	N/A
	Road Slope (%)	N/A	N/A	Clear Space?	N/A
	Road X Slope (%)	N/A	N/A	Clear Space to XWalk (in)	N/A
N/A	Any Obstructions?	N/A	N/A	Storm Grate/Utility Hazard?	N/A
	Obstruction Type			Storm Grate/Utility Type	
		N/A			N/A
			Yes	Surface Condition? (G/P)	Good

Possible Solutions:

Remove & Replace Entire Ramp.

R304.5.1
