Access Compliance Report

Public Rights-of-Way

(Curb Ramps)

Intersection ID: N/A	Main Street: YORK_CENTER	Cross Street: N/A	Location: NE
ADA ID: 508E3EF5BFDD	Ramp Type: Perp	Initial Pass/Fail: Fail	Overall Compliance: No
		Severity Score: 12.5

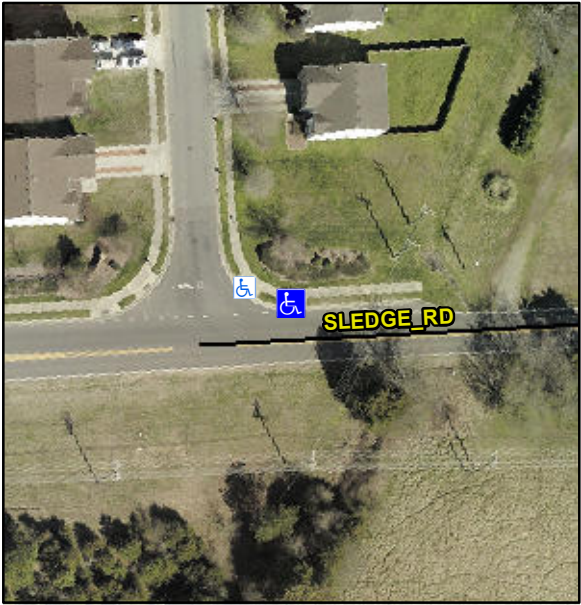
Possible Solutions:		Compliance	Description	Data
	Remove & Replace Entire Ramp.		N/A	Ramp Length (in)	48.0
			Yes	Ramp Width (in)	48.0
			N/A	Flare Type LT	N/A
			N/A	Flare Slope LT (%)	N/A
			N/A	Flare Traversable LT?	N/A
			N/A	Landing Length (in)	N/A
			N/A	Landing Width (in)	N/A
			N/A	Landing Slope (%)	N/A
			N/A	Landing X Slope (%)	N/A
			N/A	Landing Curb? (Y/N)	N/A
			N/A	Shared Landing?	N/A
			N/A	Gutter Ponding?	N/A
			N/A	Gutter Lip Ht (in)	N/A
			N/A	Painted X Walk1?	No
				X Walk 1 Direction	To S
			N/A	X Walk 1 Width (in)	N/A
				X Walk 1 Slope (%)	4.7
				X Walk 1 X Slope (%)	0.4
			N/A	Ramp inside XWalk1?	N/A
<p>Surveyor Notes:</p> <p>N/A</p> <p>PROW/ADA:</p> <p>Not Found, R304.2.2</p>			N/A	Flare Type RT	N/A
			N/A	Flare Slope RT (%)	N/A
			N/A	Flare Traversable RT?	N/A
			N/A	DWS Provided?	N/A
			N/A	DWS Contrast?	N/A
