Access Compliance Report

Public Rights-of-Way

(Curb Ramps)

Intersection ID: 15993	Main Street: PARK_RD	Cross Street: SUNSET_DR	Location: SW
ADA ID: 509161E1238A	Ramp Type: Directional1	Initial Pass/Fail: Fail	Overall Compliance: No
			Severity Score: 26.25

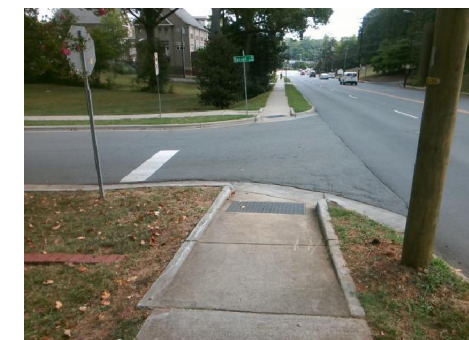
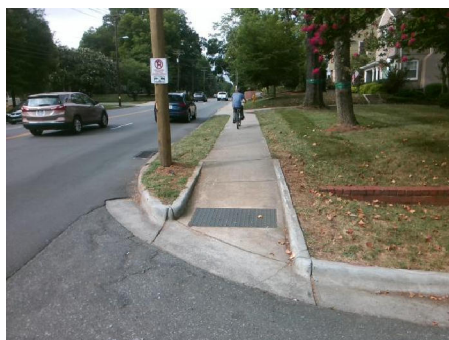
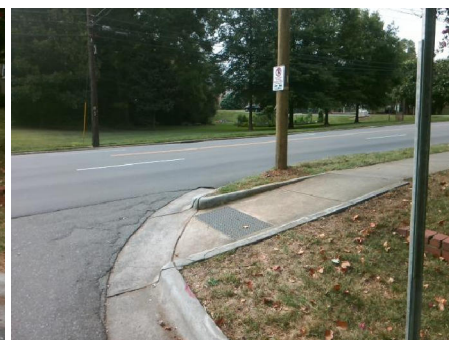
R304.2.2, R304.5.3

Compliance	Description	Data	Compliance	Description	Data
N/A	Ramp Length (in)	118.0	N/A	Grade Break?	N/A
Yes	Ramp Width (in)	59.0	N/A	Grade Break Slope (%)	0.0
No	Ramp Slope (%)	13.1	N/A	Grade Break XSlope (%)	0.0
No	Ramp XSlope (%)	3.7			
N/A	Flare Type LT	N/A	N/A	Flare Type RT	N/A
N/A	Flare Slope LT (%)	N/A	N/A	Flare Slope RT (%)	0.0
N/A	Flare Traversable LT?	N/A	N/A	Flare Traversable RT?	N/A
N/A	Landing Length (in)	0.0	N/A	DWS Provided?	N/A
N/A	Landing Width (in)	0.0	N/A	DWS Contrast?	N/A
N/A	Landing Slope (%)	0.0	N/A	DWS Length (in)	N/A
N/A	Landing X Slope (%)	0.0	N/A	DWS Full Width?	N/A
N/A	Landing Curb? (Y/N)	N/A	N/A	DWS Offset LT (in)	N/A
N/A	Shared Landing?	N/A	N/A	DWS Offset RT (in)	N/A
N/A	Gutter Ponding?	0.0	N/A	Gutter Slope (%)	N/A
N/A	Gutter Lip Ht (in)	0.0	N/A	Gutter X Slope (%)	N/A
N/A	Painted X Walk1?	No		Road Slope (%)	3.1
	X Walk 1 Direction	To N		Road X Slope (%)	9.2
	X Walk 1 Width (in)	N/A		Clear Space?	N/A

X Walk 1 Slope (%)	3.1	N/A	Clear Space to XWalk (in)	N/A
	X Walk 1 X Slope (%)	9.2	N/A	Storm Grate/Utility Hazard?	N/A
N/A	Ramp inside XWalk1?	N/A		Storm Grate/Utility Type	
N/A	Any Obstructions?	N/A			N/A
	Obstruction Type		Yes	Surface Condition? (G/P)	Good
			N/A	Curb Slope (%)	6.2

Remove & Replace Entire Ramp.
