# Access Compliance Report

## Public Rights-of-Way

### (Curb Ramps)

Intersection ID: 25491	Main Street: SOUTHBRIDGE_FOREST_DR	Cross Street: CANE_FIELD_DR	Location: NE
ADA ID: 50964BF11D03	Ramp Type: PerpDiag	Initial Pass/Fail: Fail	Overall Compliance: No
Severity Score: 12.5			
Codes/Mitigation Info/Possible Solution		Field Measurements/Component Compliance

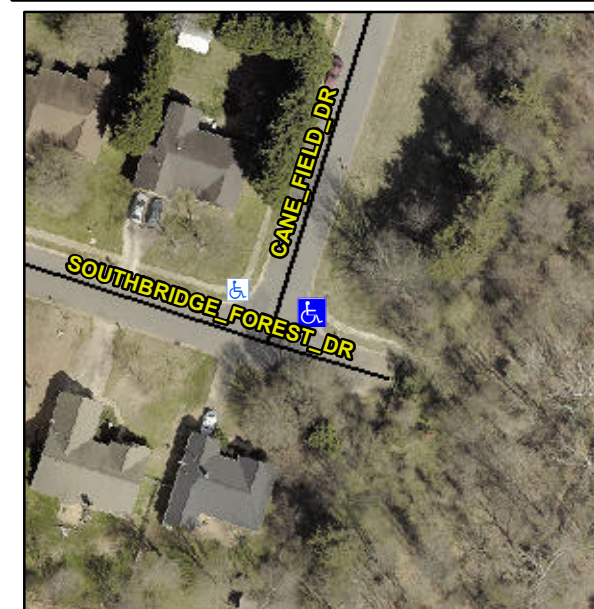
Compliance	Description	Data	Compliance	Description	Data
N/A	Ramp Length (in)	58.0	No	Ramp Slope (%)	9.5
Yes	Ramp Width (in)	48.0	Yes	Ramp XSlope (%)	0.4
N/A	Flare Type LT	N/A	N/A	Flare Type RT	N/A
N/A	Flare Slope LT (%)	N/A	N/A	Flare Slope RT (%)	N/A
N/A	Flare Traversable LT?	N/A	N/A	Flare Traversable RT?	N/A
N/A	Landing Length (in)	N/A	N/A	DWS Provided?	N/A
N/A	Landing Width (in)	N/A	N/A	DWS Contrast?	N/A
N/A	Landing Slope (%)	N/A	N/A	DWS Length (in)	N/A
N/A	Landing X Slope (%)	N/A	N/A	DWS Full Width?	N/A
N/A	Landing Curb? (Y/N)	N/A	N/A	DWS Offset (in)	N/A
N/A	Shared Landing?	N/A			
N/A	Gutter Ponding?	N/A	N/A	Gutter Slope (%)	N/A
N/A	Gutter Lip Ht (in)	N/A	N/A	Gutter X Slope (%)	N/A
N/A	Painted X Walk1?	No	N/A	Painted X Walk2?	No
	X Walk 1 Direction	To NW		X Walk 2 Direction	To SW
N/A	X Walk 1 Width (in)	N/A	N/A	X Walk 2 Width (in)	N/A
	X Walk 1 Slope (%)	4.9		X Walk 2 Slope (%)	3.5
	X Walk 1 X Slope (%)	0.1		X Walk 2 X Slope (%)	1.1

N/A	Ramp inside XWalk1?	N/A	N/A	Ramp inside XWalk2?	N/A
	Road Slope (%)	0.5	N/A	Clear Space?	N/A
	Road X Slope (%)	2.6	N/A	Clear Space to XWalk (in)	N/A
N/A	Any Obstructions?	N/A	N/A	Storm Grate/Utility Hazard?	N/A
	Obstruction Type			Storm Grate/Utility Type	
		N/A			N/A
			Yes	Surface Condition? (G/P)	Good

**Remove & Replace Curb Ramp With Two New Directional Ramps or Equivalent.**

**R304.2.2**

**\$ 3200.00**
