Access Compliance Report

Public Rights-of-Way

(Curb Ramps)

Intersection ID: N/A	Main Street: NEW_FASHION_WY	Cross Street: N/A	Location: S
ADA ID: 5098B9B9E478	Ramp Type: Perp	Initial Pass/Fail: Fail	Overall Compliance: No
		Severity Score: 25

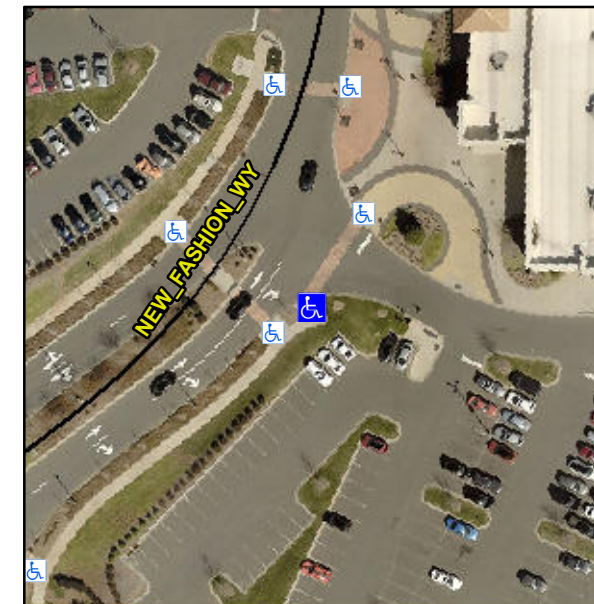
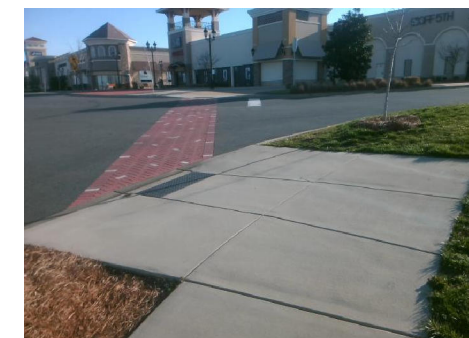
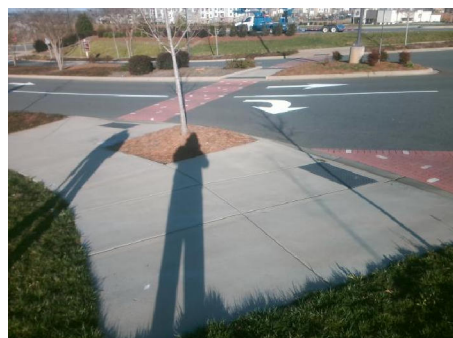
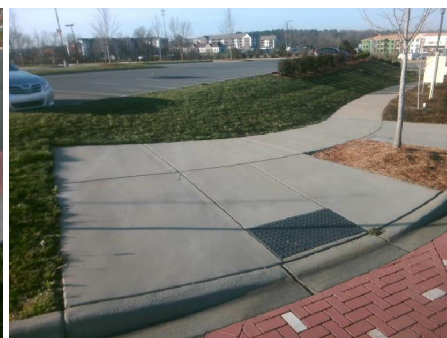
Compliance	Description	Data	Compliance	Description	Data
N/A	Ramp Length (in)	99.0	Yes	Ramp Slope (%)	7.8
Yes	Ramp Width (in)	48.0	No	Ramp XSlope (%)	9.5
N/A	Flare Type LT	N/A	N/A	Flare Type RT	N/A
N/A	Flare Slope LT (%)	N/A	N/A	Flare Slope RT (%)	N/A
N/A	Flare Traversable LT?	N/A	N/A	Flare Traversable RT?	N/A
N/A	Landing Length (in)	N/A	N/A	DWS Provided?	N/A
N/A	Landing Width (in)	N/A	N/A	DWS Contrast?	N/A
N/A	Landing Slope (%)	N/A	N/A	DWS Length (in)	N/A
N/A	Landing X Slope (%)	N/A	N/A	DWS Full Width?	N/A
N/A	Landing Curb? (Y/N)	N/A	N/A	DWS Offset (in)	N/A
N/A	Shared Landing?	N/A			
N/A	Gutter Ponding?	N/A	N/A	Gutter Slope (%)	N/A
N/A	Gutter Lip Ht (in)	N/A	N/A	Gutter X Slope (%)	N/A
N/A	Painted X Walk1?	Yes	N/A	Painted X Walk2?	N/A
	X Walk 1 Direction	To NE		X Walk 2 Direction	N/A
N/A	X Walk 1 Width (in)	81.0	N/A	X Walk 2 Width (in)	N/A
	X Walk 1 Slope (%)	8.0		X Walk 2 Slope (%)	N/A
	X Walk 1 X Slope (%)	3.8		X Walk 2 X Slope (%)	N/A

N/A	Ramp inside XWalk1?	Yes	N/A	Ramp inside XWalk2?	N/A
	Road Slope (%)	N/A	N/A	Clear Space?	N/A
	Road X Slope (%)	N/A	N/A	Clear Space to XWalk (in)	N/A
N/A	Any Obstructions?	N/A	N/A	Storm Grate/Utility Hazard?	N/A
	Obstruction Type			Storm Grate/Utility Type	
		N/A			N/A
		Yes		Surface Condition? (G/P)	Good

Possible Solutions:

Remove & Replace Entire Ramp.

R304.5.3
